## NATURAL RESOURCE CONSERVATION MANAGEMENT FIVE YEAR IMPLEMENTATION PLAN

### CAMP GEIGER

## PONY EXPRESS COUNCIL BSA

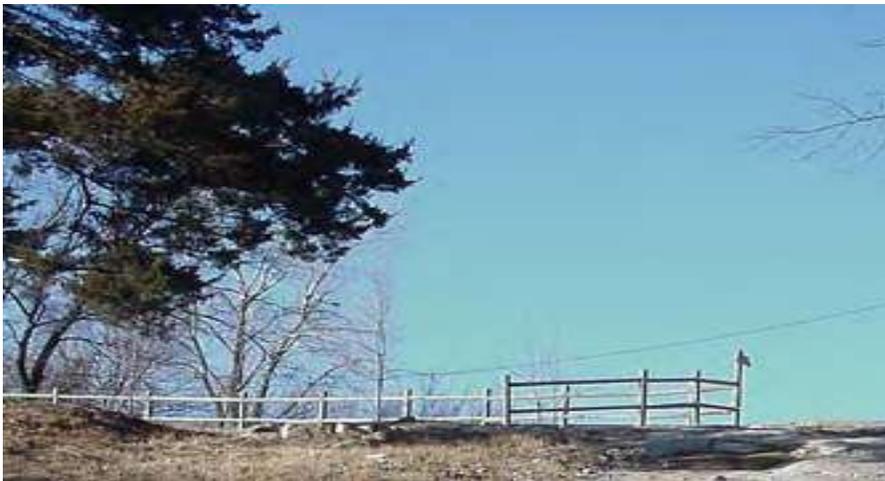
Erosion on Entrance to Camp Pueblo and Apache

The Missouri Department of Conservation has offered to use their heavy equipment to help restructure soil erosion problems. This in-kind labor would be used as a typical State Cost share practice. The use of MDC's labor and equipment should be available throughout the next couple of years with prior approval and scheduling through local MDC Private Land Services. Possible sites for MDC cooperation may include the road entrance to Pueblo Camp Site, Rifle Range Trail, and the road to the COPE Coarse.

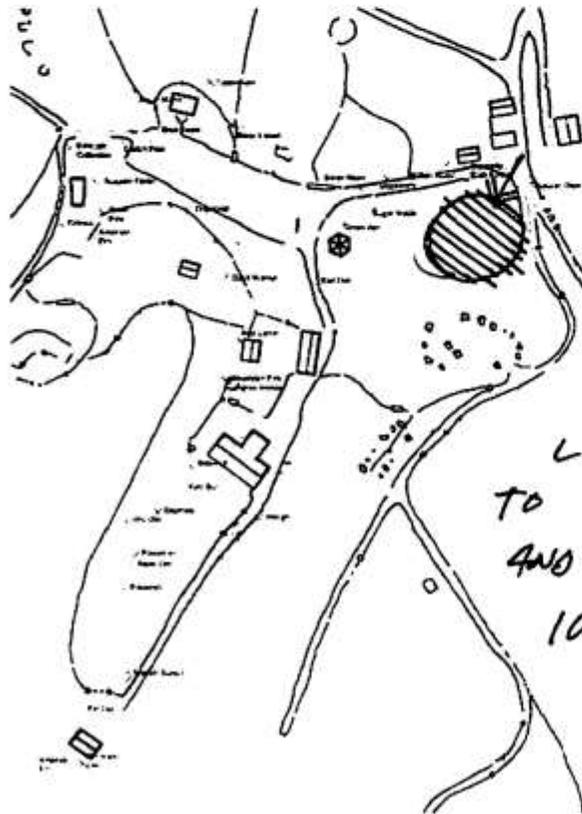
A NEW STORMWATER DETENTION DAM HAS BEEN CONSTRUCTED TO PROTECT EROSION ON THE CAMP ROAD TO THE OLDER CAMPSITES. IT HAS ALREADY BEEN SEEDED AND IS STARTING TO GROW. STRAW MUST BE LOOSLY PLACE OVER THE GRASS TO AID IN MOISTURE RETENTION AND TO BREAK THE EFFECTS OF RAIN. 10 TO 12 BALES OF STRAW SHOULD BE SUFFICIENT. DO NOT PLACE STRAW TOO THICK. PLACE THE STRAW ONLY OVER DISTURBED SOIL.

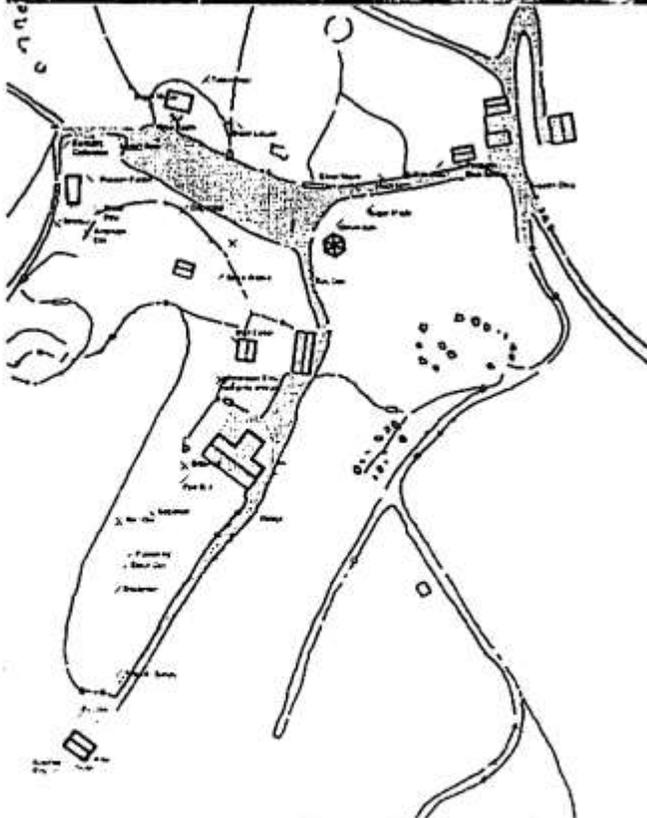
The trail to the rifle range was recently graded and is very muddy. The trail ruts easily when wet. That increases erosion. The water has no way to leave the surface other than to continue down the road.

Excess material should be removed from the side of the road to allow moisture to drain away. The excess material removed should be used to create a water diverter (terrace) to the downhill side of the path.

These chips should be available from the camp ranger.

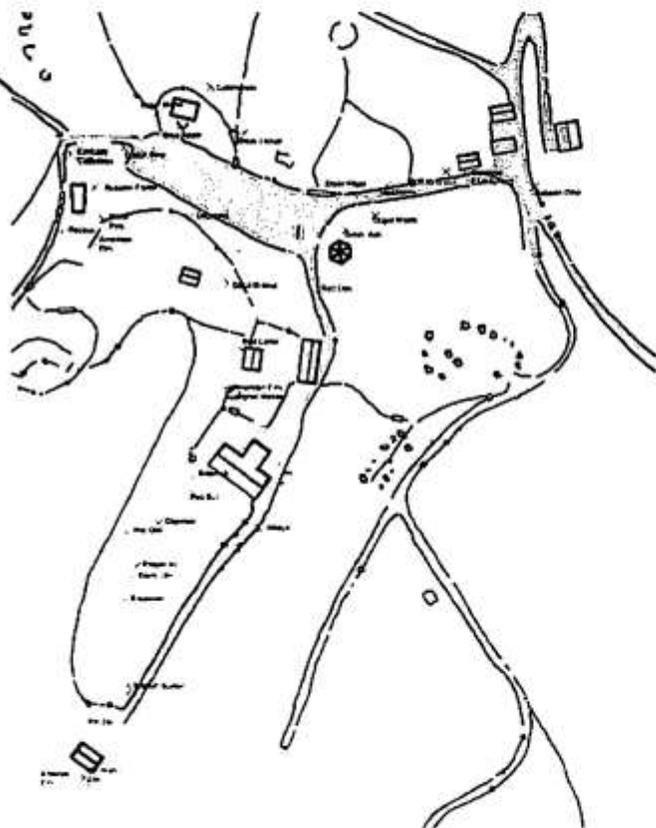
PHOTO  
CUT OUT

CUT OUT  
WOODY  
ENCROACHMENTS.

This hillside was originally native prairie grasses. The woody vegetative encroachments should be cut and large stumps treated with a broadleaf herbicide to prevent future growth. Cut material as low to the ground as possible. Remove all material which has been cut. At least pull to the road. Remove only to the thick stands of hardwood trees.

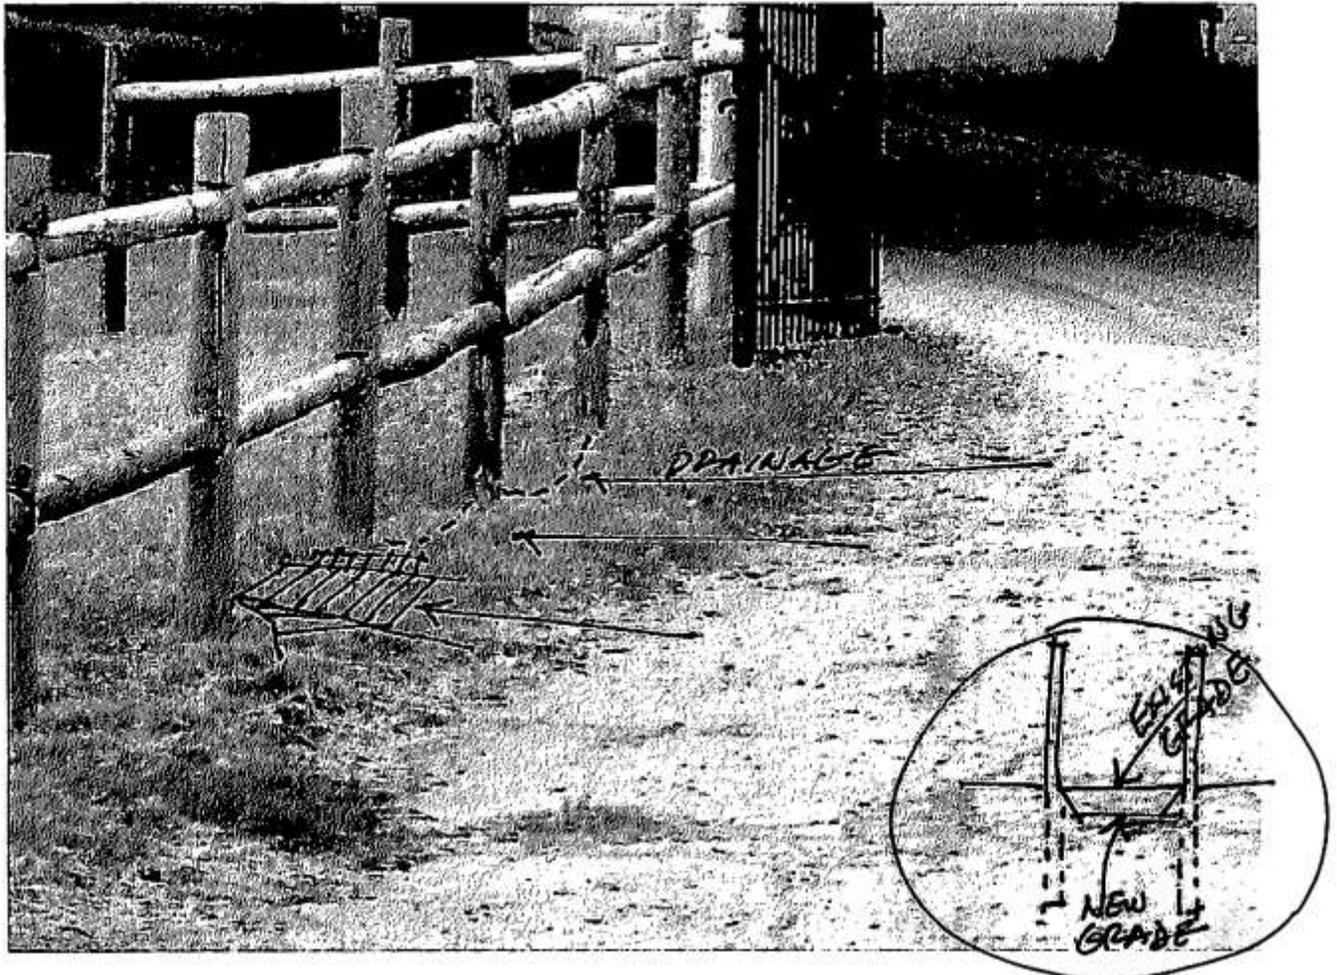
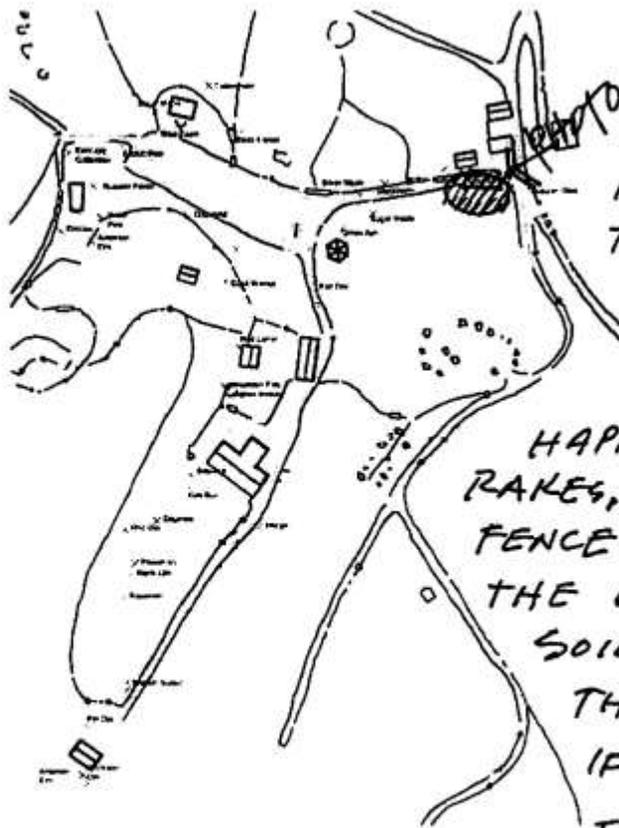
A NEW DETENTION POND HAS BEEN CONSTRUCTED BELOW THE MAIN ENTRY DRIVE ACROSS FROM THE RANGERS HOUSE. THE PAVED DRIVE SHOULD DRAIN TO THAT DETENTION POND, BUT EARTH DEPOSITES BENEATH THE FENCE PREVENT THAT FROM HAPPENING. USING SHOVELS, PICKS, AND RAKES, DIG OUT MATERIAL FROM BETWEEN FENCE POSTS TO ALLOW DRAINAGE TO THE DETENTION BASIN. LOOSEN THE SOIL, RAKE SMOOTH, AND RESEED THE AREA DISTURBED. MULCH IF AVAILABLE. START ONLY THE AREAS YOU WILL BE ABLE TO COMPLETE. START AT THE WEST END. PLACE EXCESS DIRT IN THE RUTS AT THE EAST END OF THE FENCE.

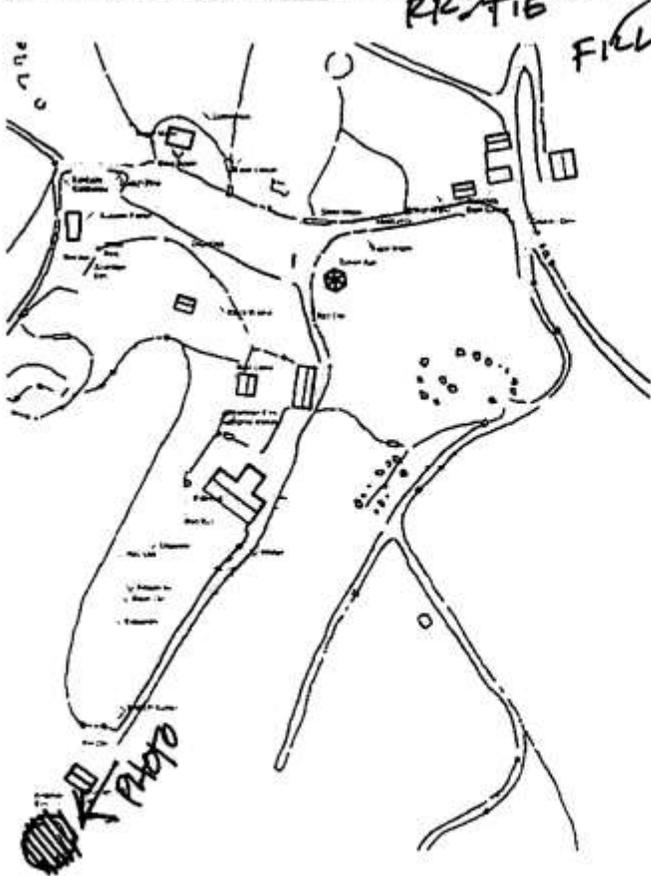
The head of the nature trail directly south of the Nature Lodge is beginning to show signs of drainage erosion. Precautions need to be taken to assure that drainage is diverted from the trail. This can be done most easily by installing some form of device to change the course of the water. Something like a RR tie would be an easy diversion if it were buried at the head of the trail and then dirt should be filled in on the north side to help the water find a new course.

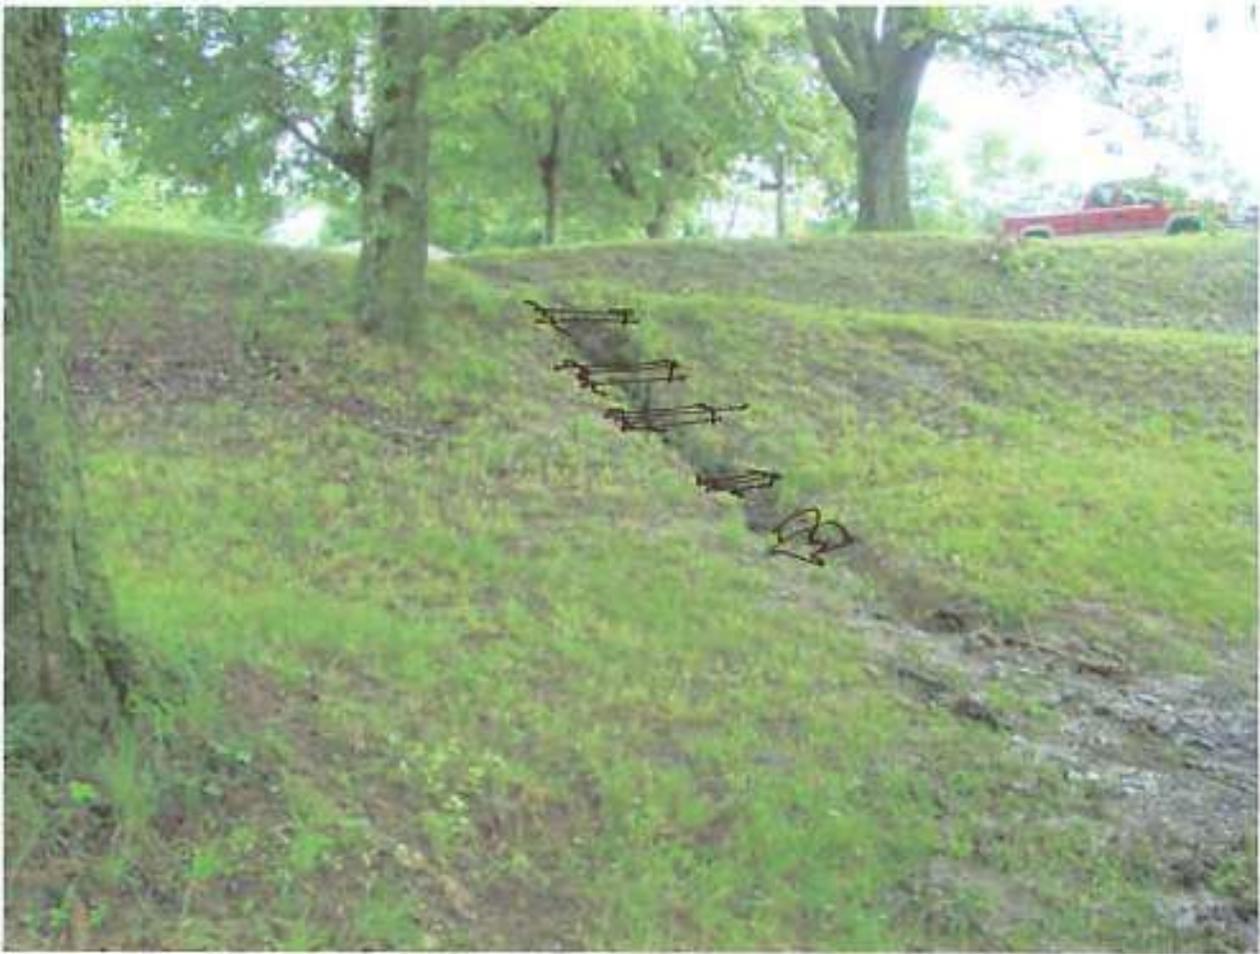
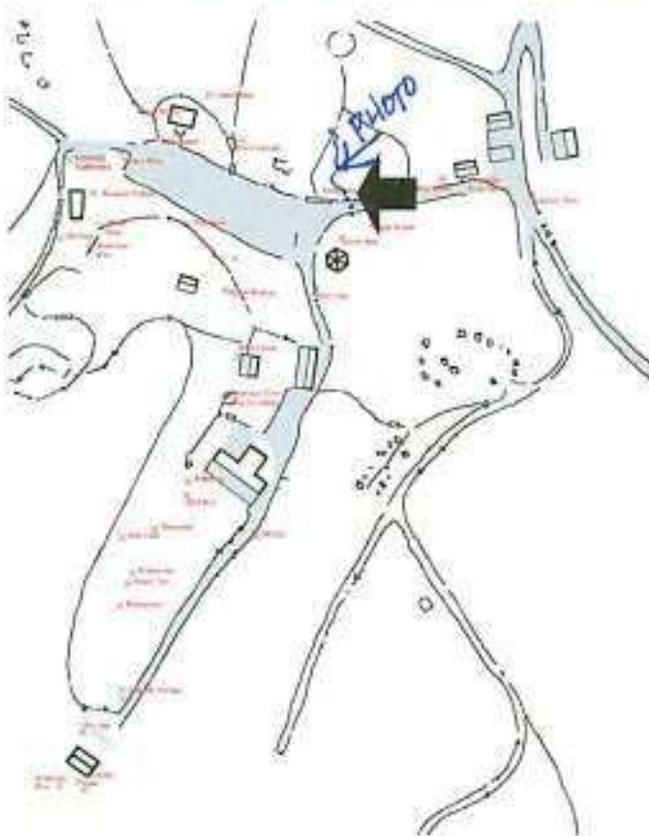
The Geiger parking lot drains during heavy rains to this area just north of the handicraft pavilion. Smaller rains are handled by an inlet and drainage tube in the parking lot to the west. The drainage is washing out a drainage ditch that will continue to grow unless repaired.

Start only the areas you will be able to complete.

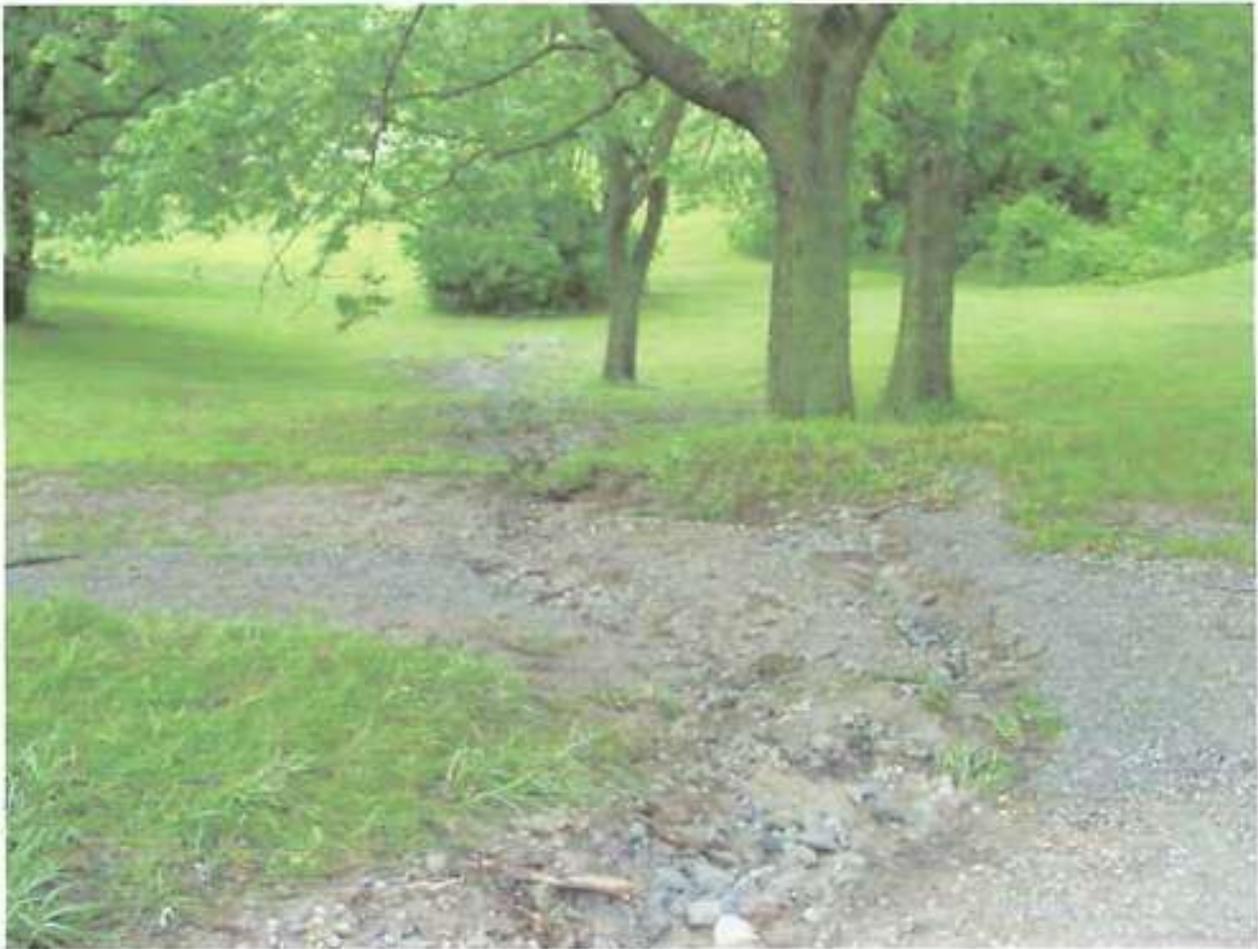
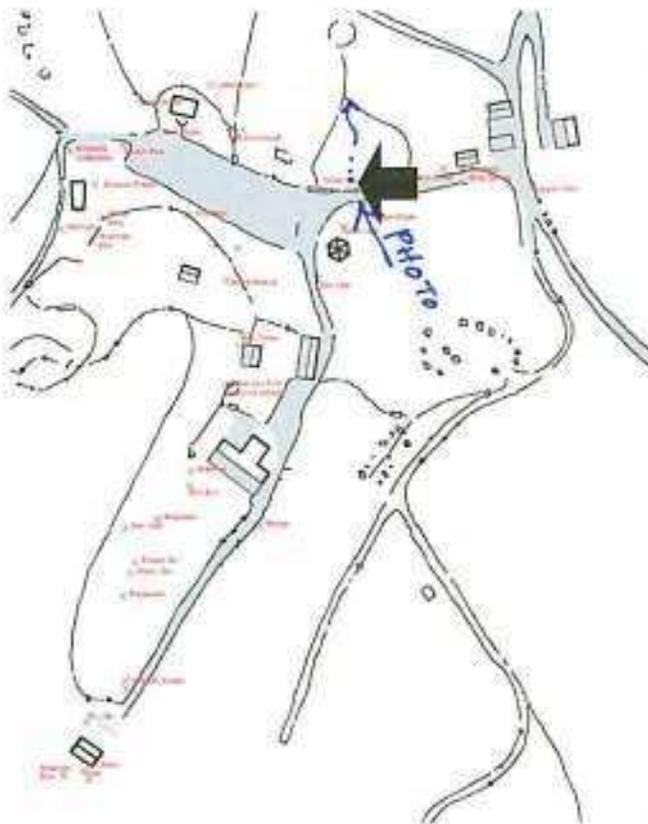
The Geiger parking lot drains during heavy rains to this area just north of the handicraft pavilion. Smaller rains are handled by an inlet and drainage tube in the parking lot to the west. The drainage is washing out a drainage ditch that will continue to grow unless repaired.

Start only the areas you will be able to complete.

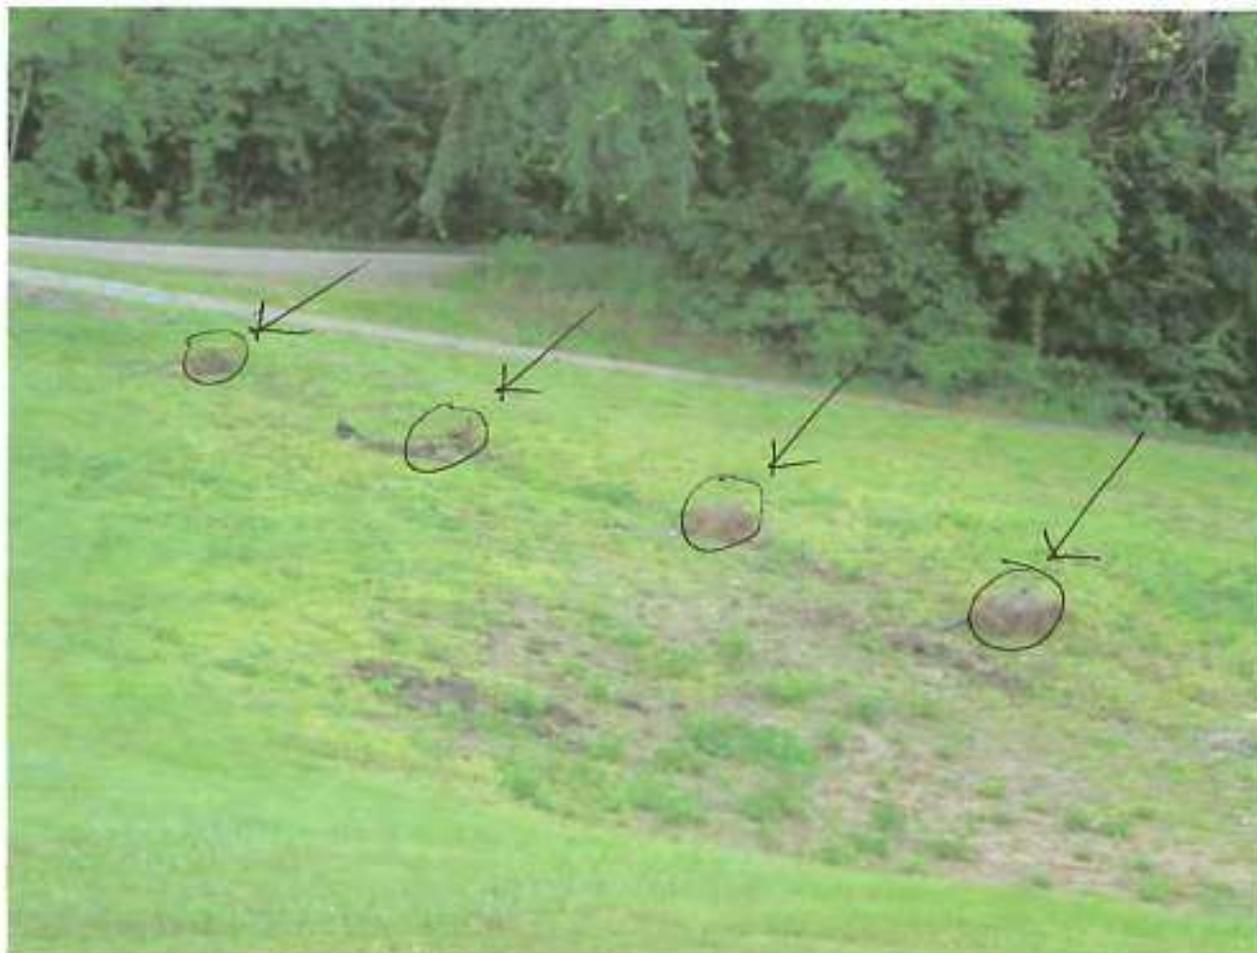
The stromwater detention area was created a year ago to protect the adjacent roadway from erosion. The hay bales were used as check dams to slow drainage.

Remove any nonorganic matter for proper disposal. Grade the distrubed area with shovels and garden rakes. Seed only if needed.

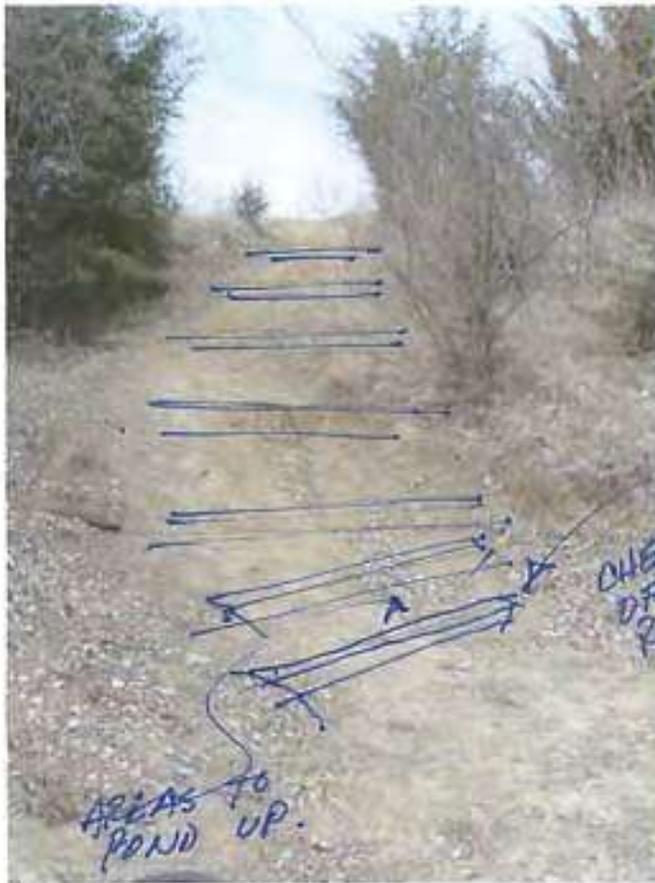
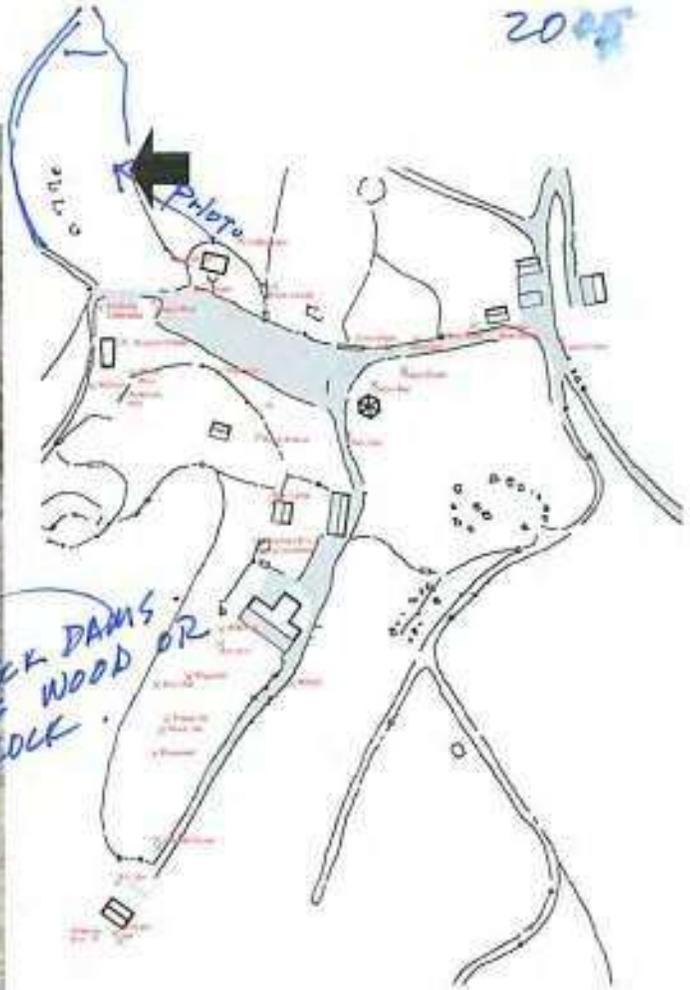
There is a trail cut between the swimming pool ridge and the scoutcraft valley that has begun to erode because of the steep grade. The drainage is washing out a ditch that will continue to grow unless repaired.

The necessary tools and materials may be obtained from the quartermaster and the camp ranger. Be certain to line up materials and tools well before you plan to perform the work.

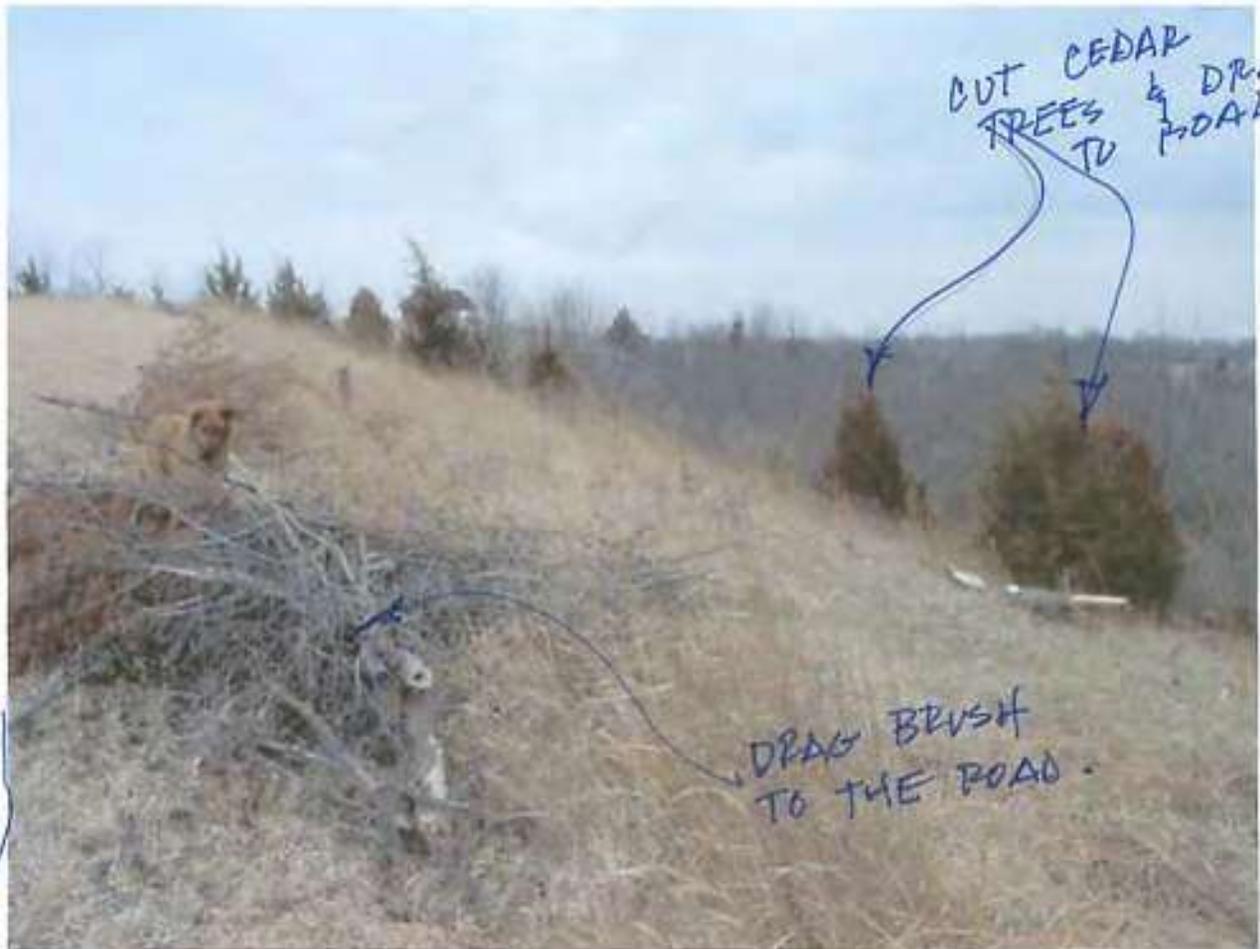
This hillside was originally native prairie grasses. The woody vegetative encroachments should be cut and large stumps treated with a broadleaf herbicide to prevent future growth.

Cut material as low to the ground as possible. Remove all material which has been cut. At least pull to the road. The cut material previously cut and left on the banks should be drug to the top of the hill where they can be hauled off.

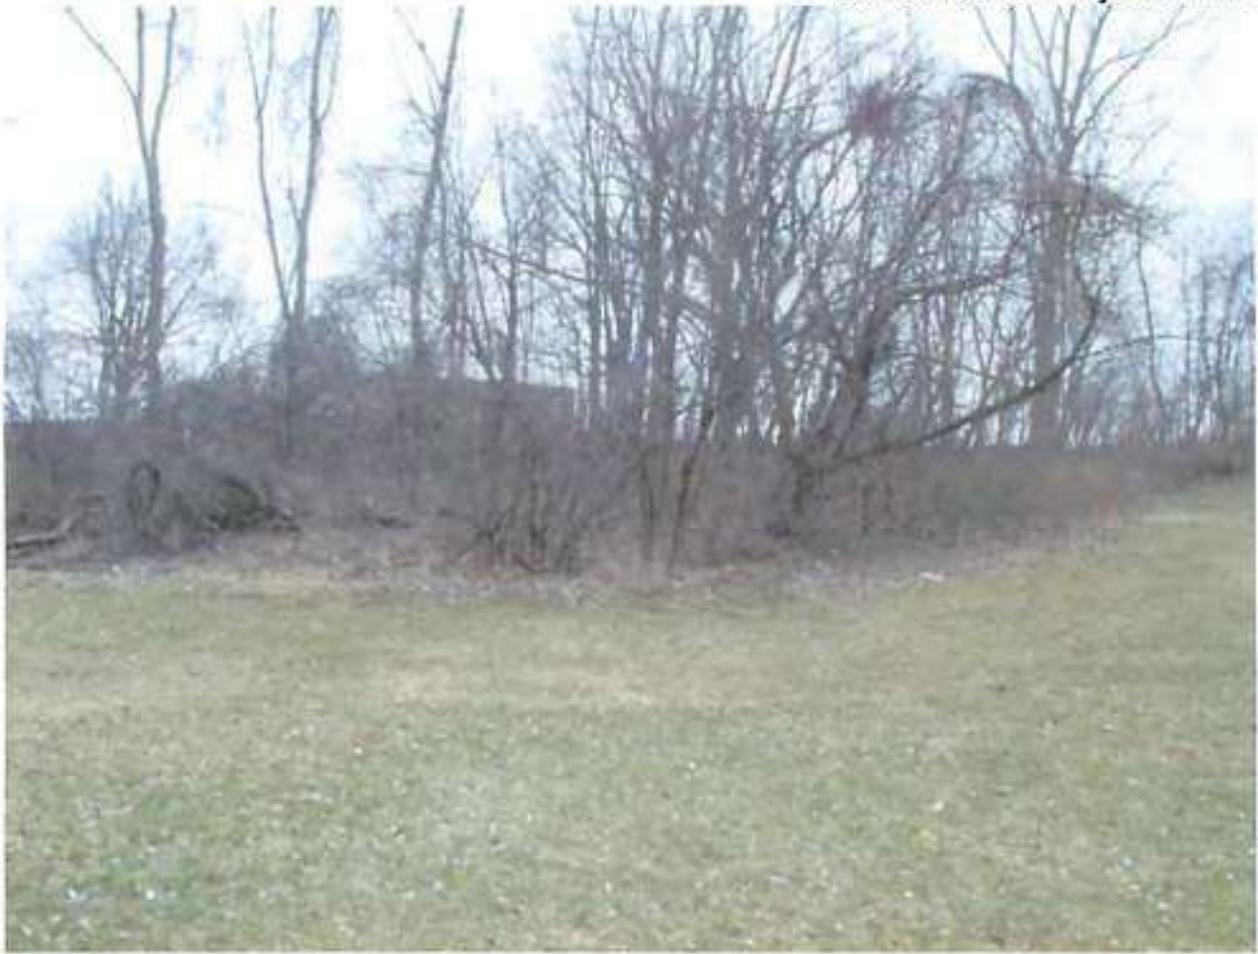
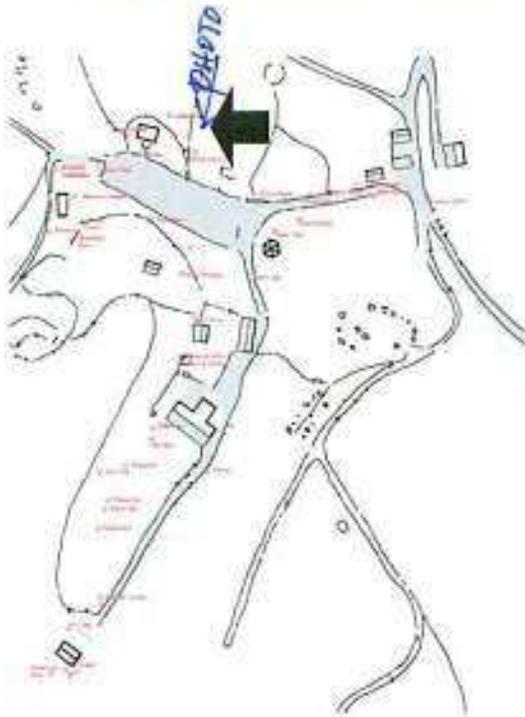
This hillside just south of Tapper Valley has a wooded area that has not been cleaned out for a long time. That covering of dead and decaying material presents a fire hazard and stops new vegetation growth that will help prevent erosion.

The necessary tools and materials may be obtained from the quartermaster and the camp ranger. Be certain to line up materials and tools well before you plan to perform the work.

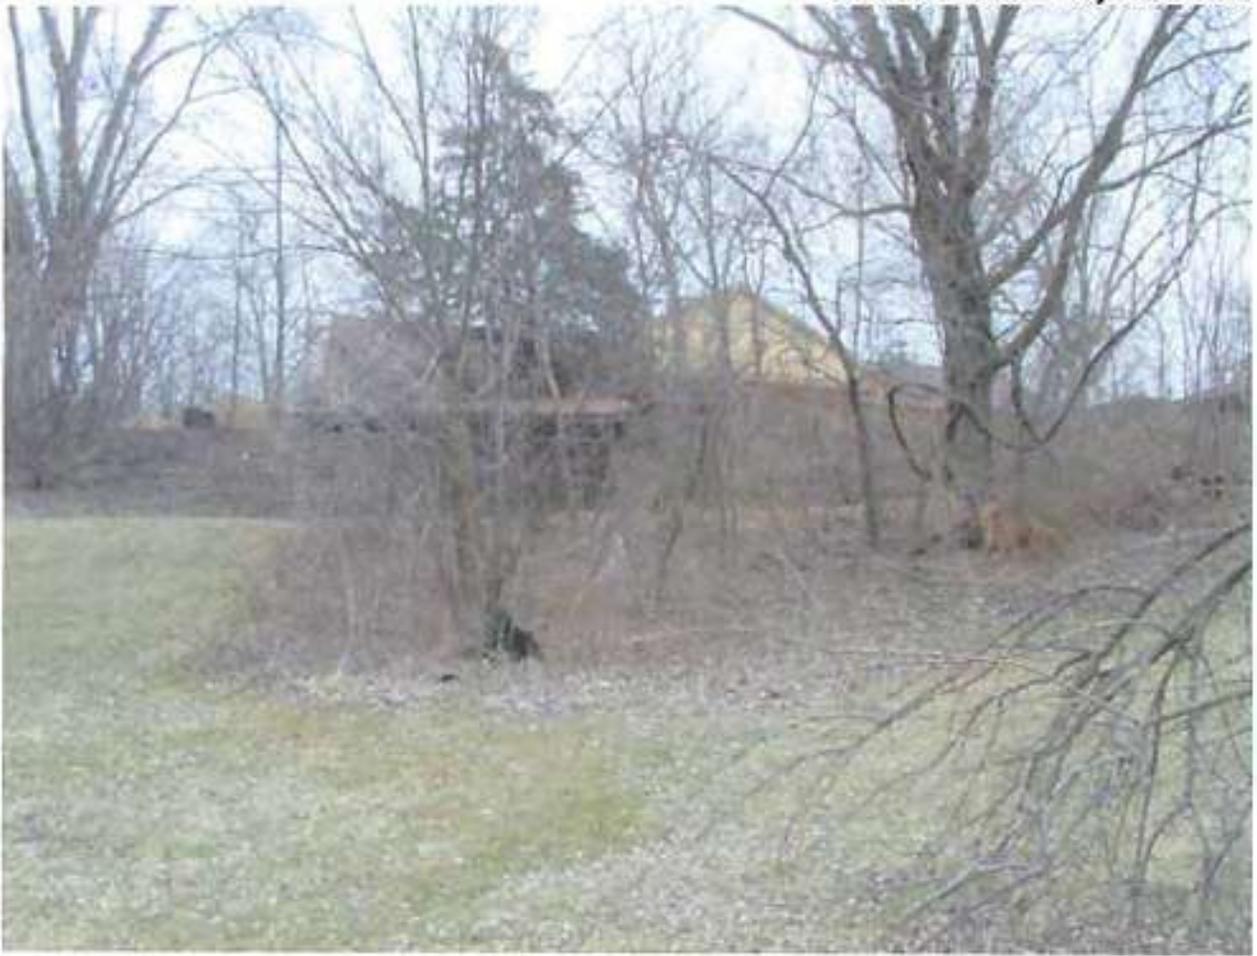
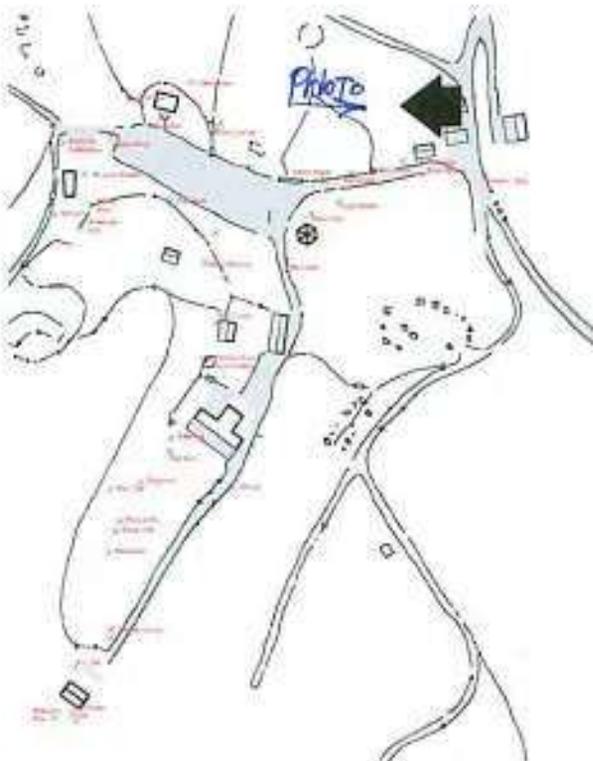
This hillside just east of Tapper Valley and west of the Noisy Crow Trading Post has a wooded area that has not been cleaned out for a long time. That covering of dead and decaying material presents a fire hazard and stops new vegetation growth that will help prevent erosion.

The necessary tools and materials may be obtained from the quartermaster and the camp ranger. Be certain to line up materials and tools well before you plan to perform the work.

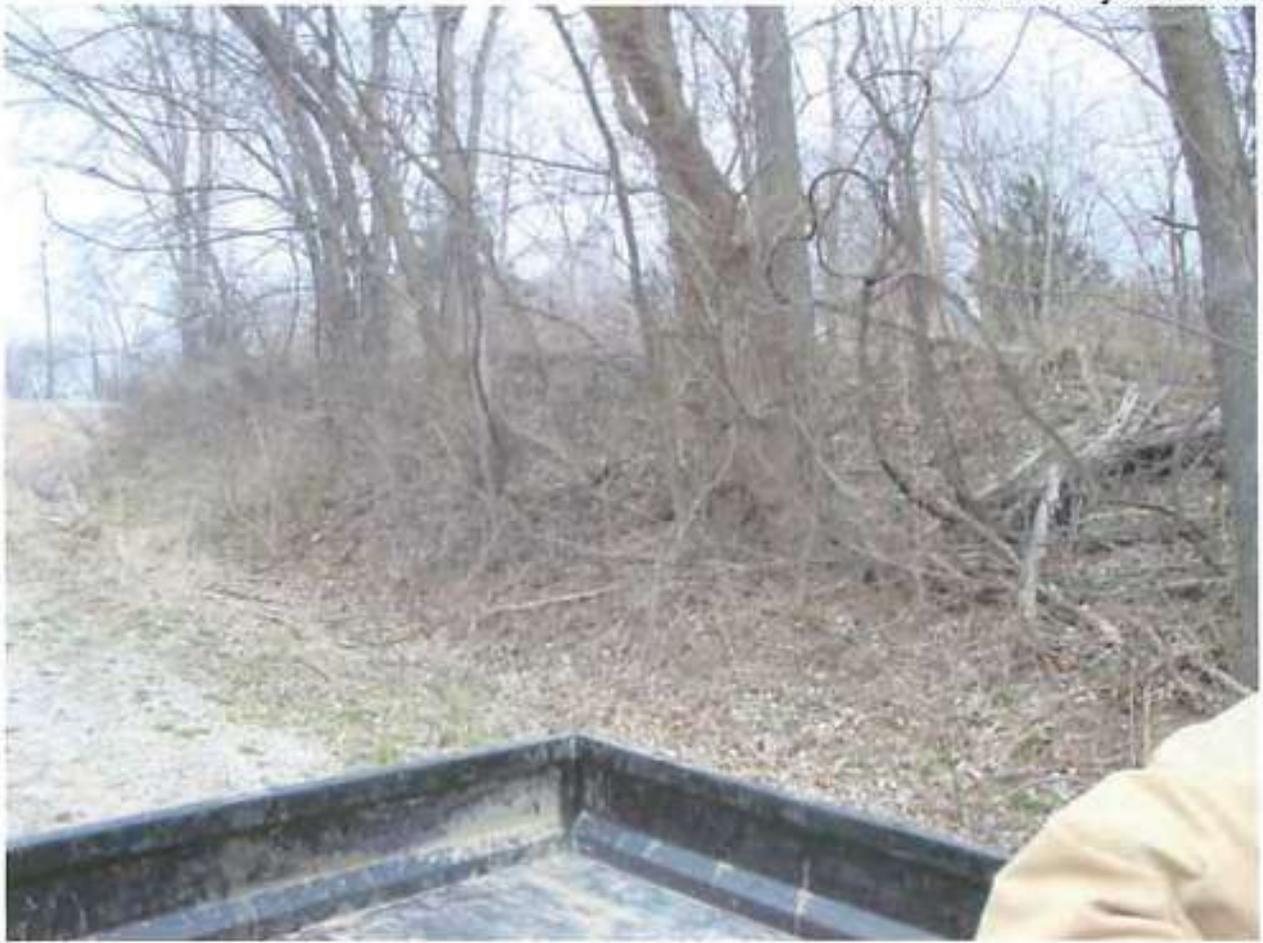
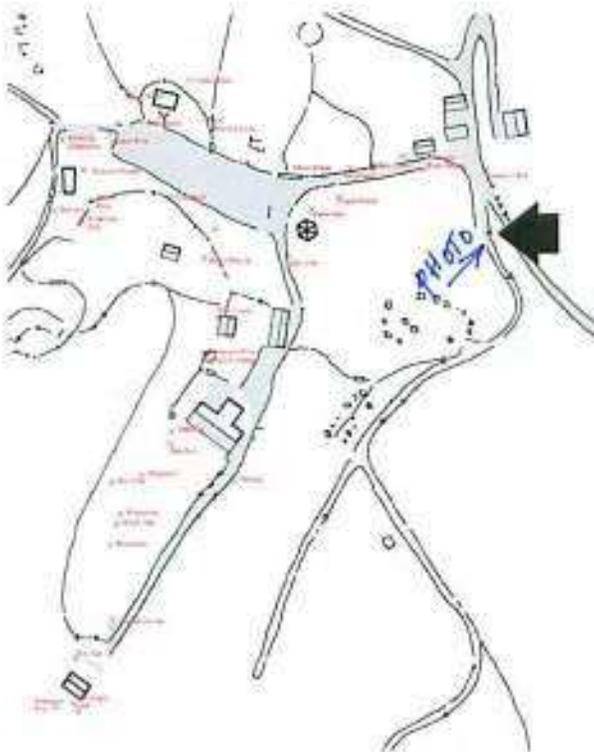
This hillside just west of the main entry drive shown on the plan to the left has a wooded area that has not been cleaned out for a long time. That covering of dead and decaying material presents a fire hazard and stops new vegetation growth that will help prevent erosion.

The necessary tools and materials may be obtained from the quartermaster and the camp ranger. Be certain to line up materials and tools well before you plan to perform the work.

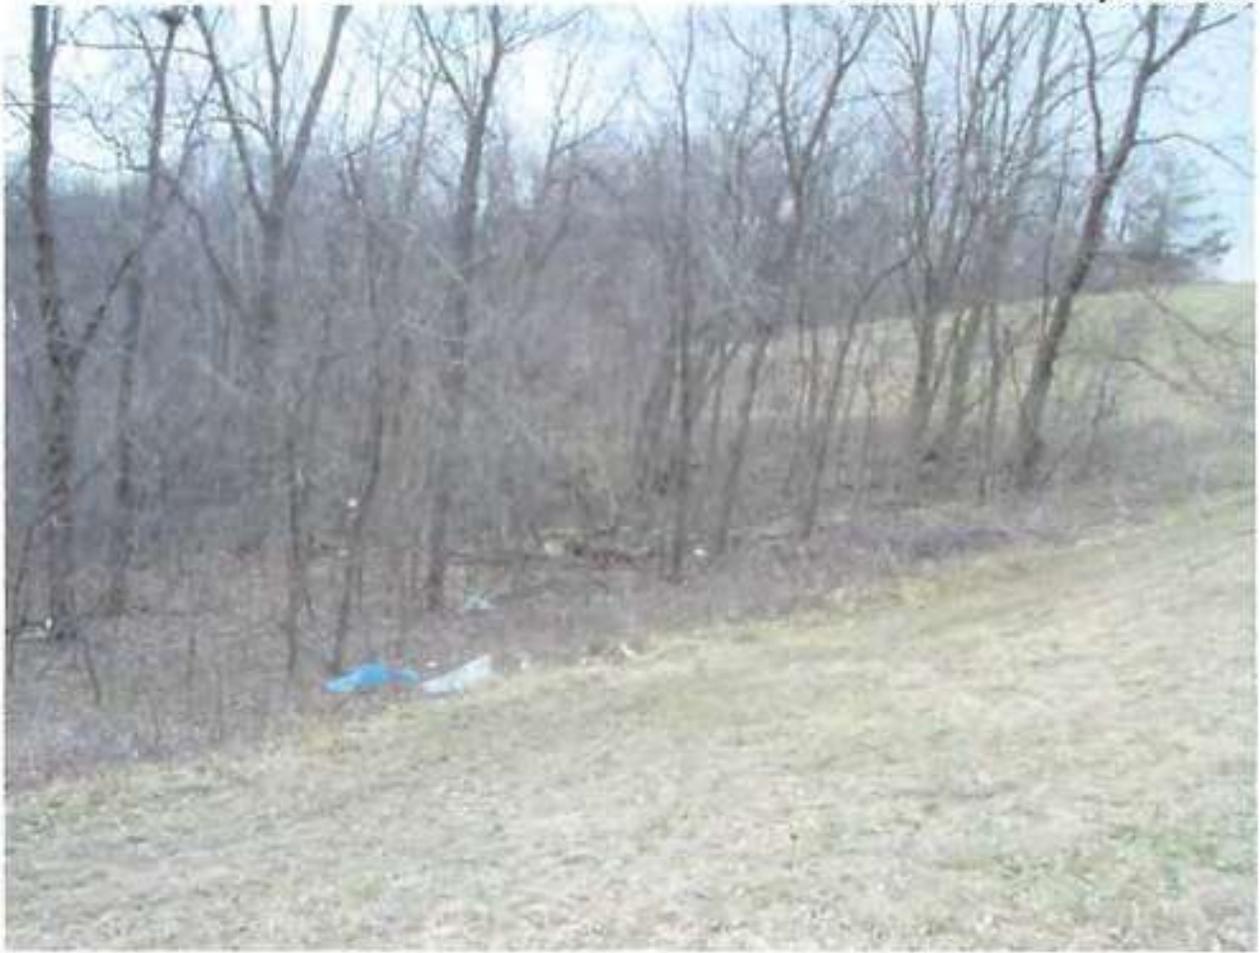
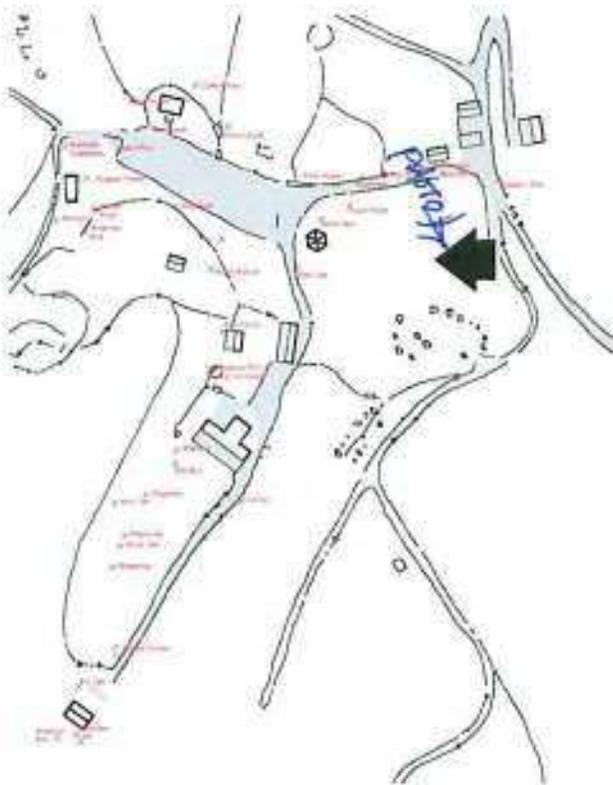
This hillside between Pueblo Village and the new erosion check dam has a wooded area that has not been cleaned out for a long time. That covering of dead and decaying material presents a fire hazard and stops new vegetation growth that will help prevent erosion.

The necessary tools and materials may be obtained from the quartermaster and the camp ranger. Be certain to line up materials and tools well before you plan to perform the work.

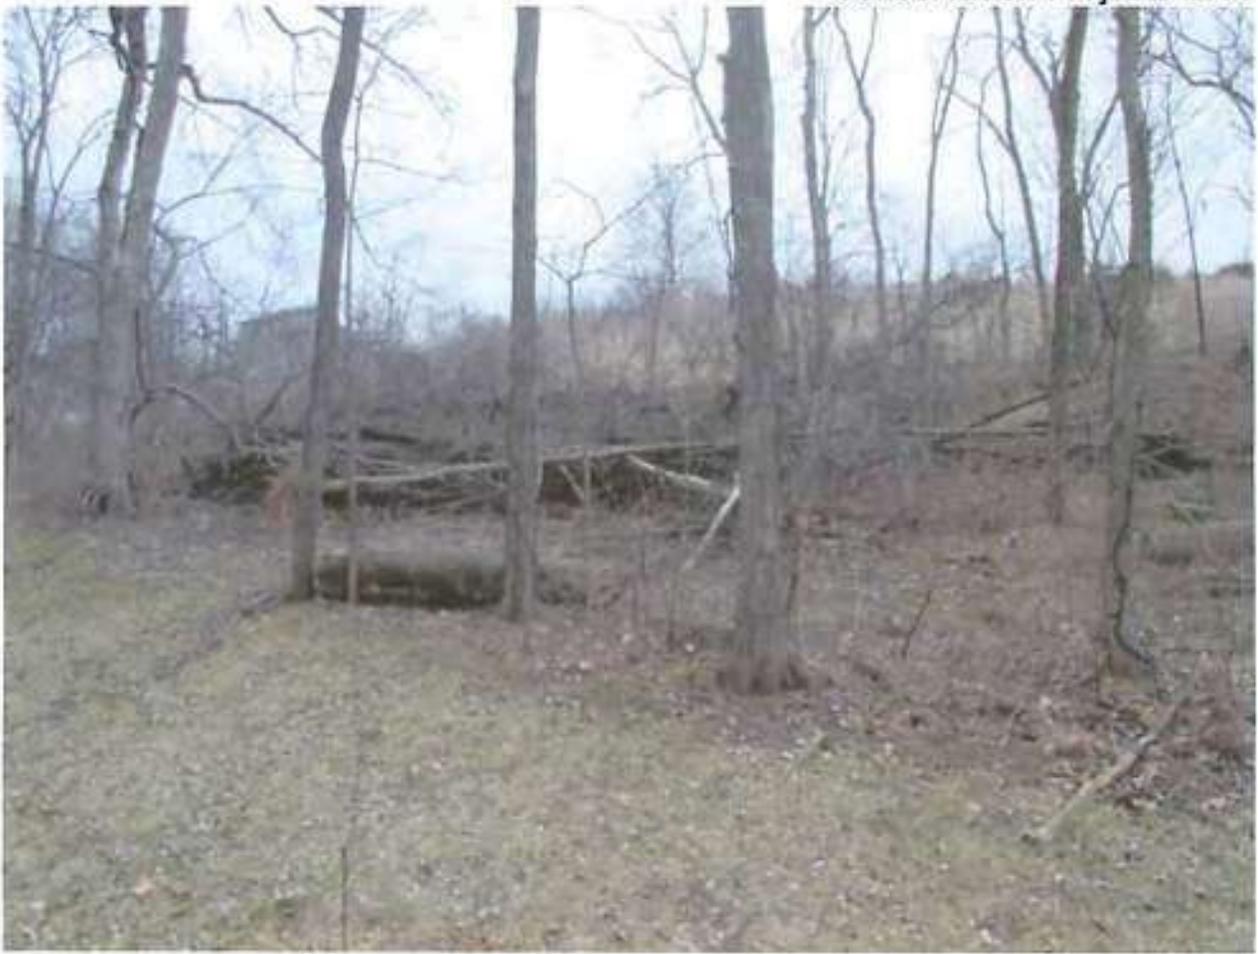
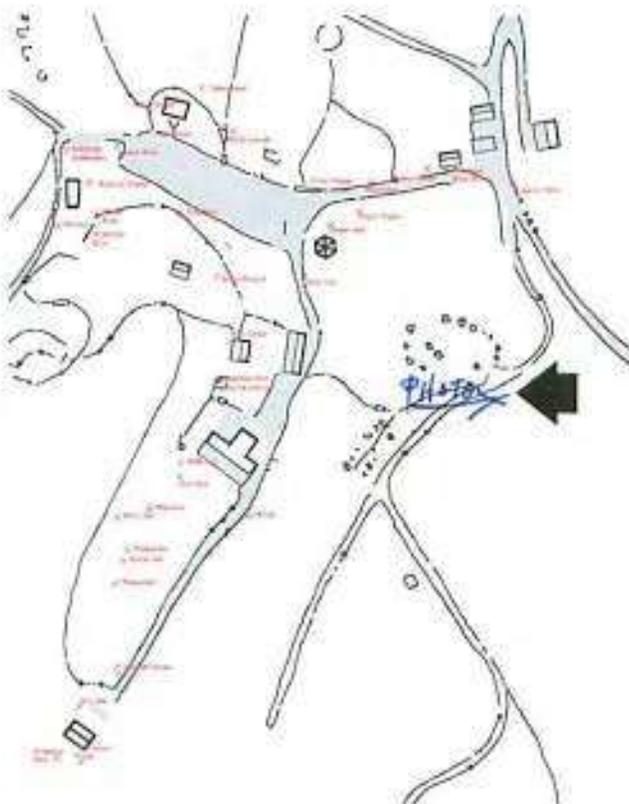
This hillside just east of the road to "south camp" has a wooded area that has not been cleaned out for a long time. That covering of dead and decaying material presents a fire hazard and stops new vegetation growth that will help prevent erosion.
