## NATURAL RESOURCE CONSERVATION MANAGEMENT FIVE YEAR IMPLEMENTATION PLAN

### CAMP GEIGER

## PONY EXPRESS COUNCIL BSA

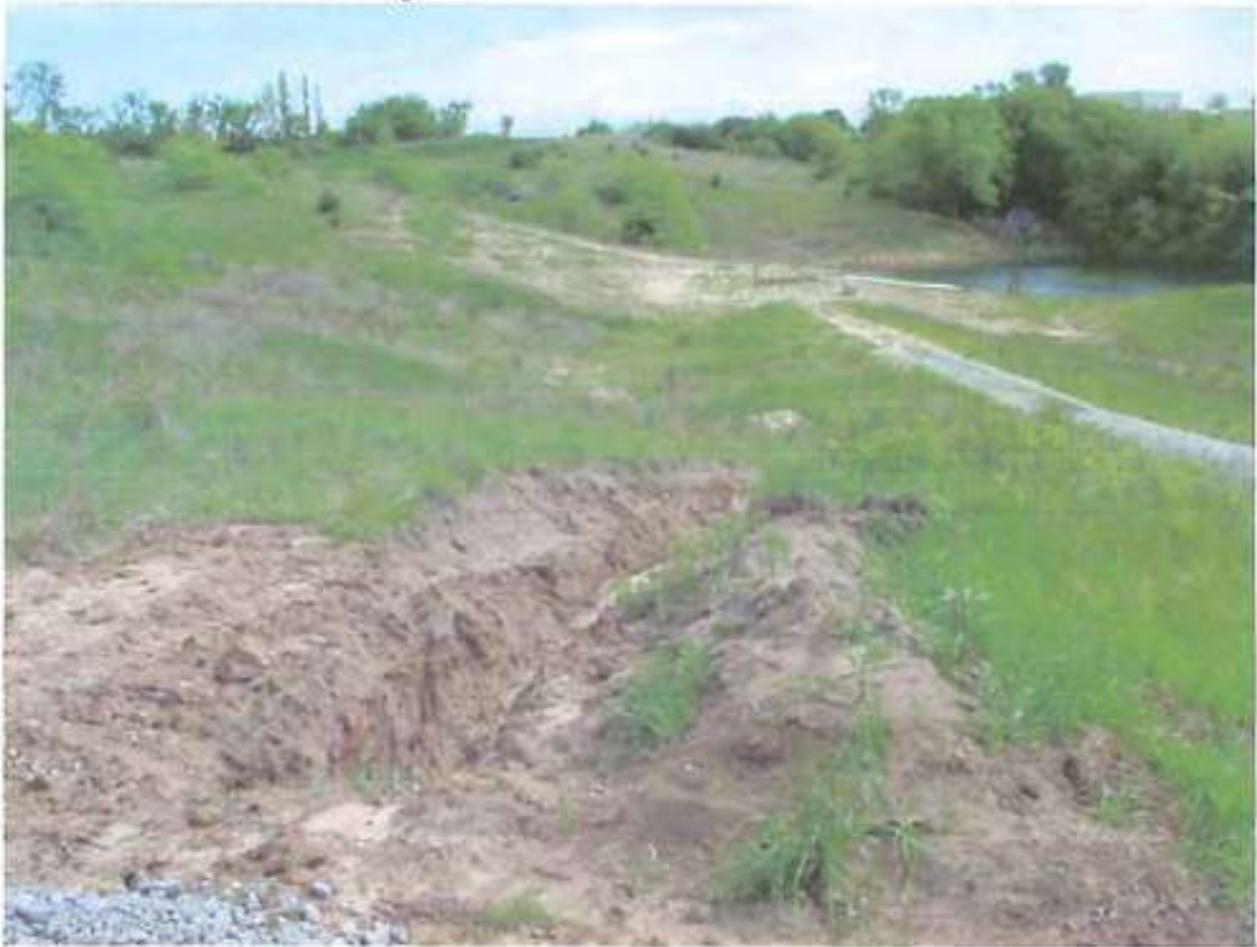
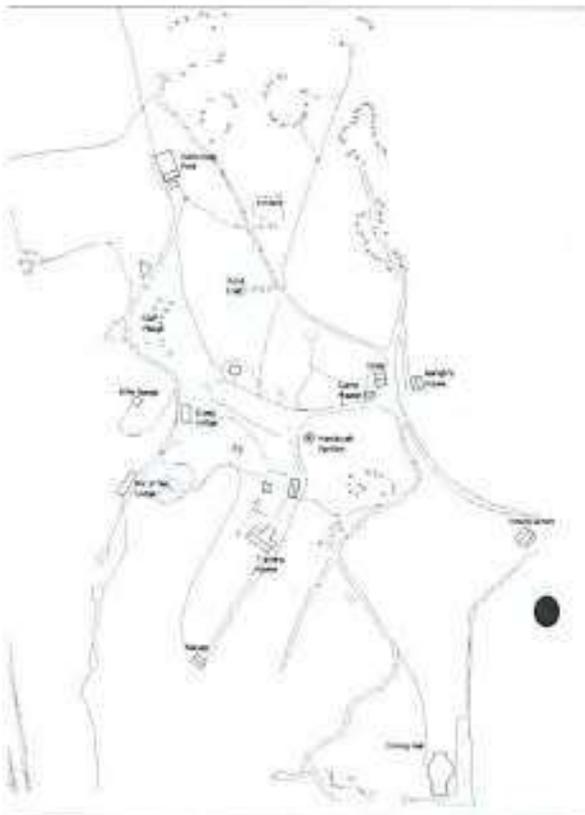
**The Problem** – A new road has been built to Richardson Lake. A drainage tube has been installed at a bend midway down the road. The Tube has been installed, but the ground has not been finished and reseeded. The drainage is washing out a drainage ditch that will continue to grow unless repaired.

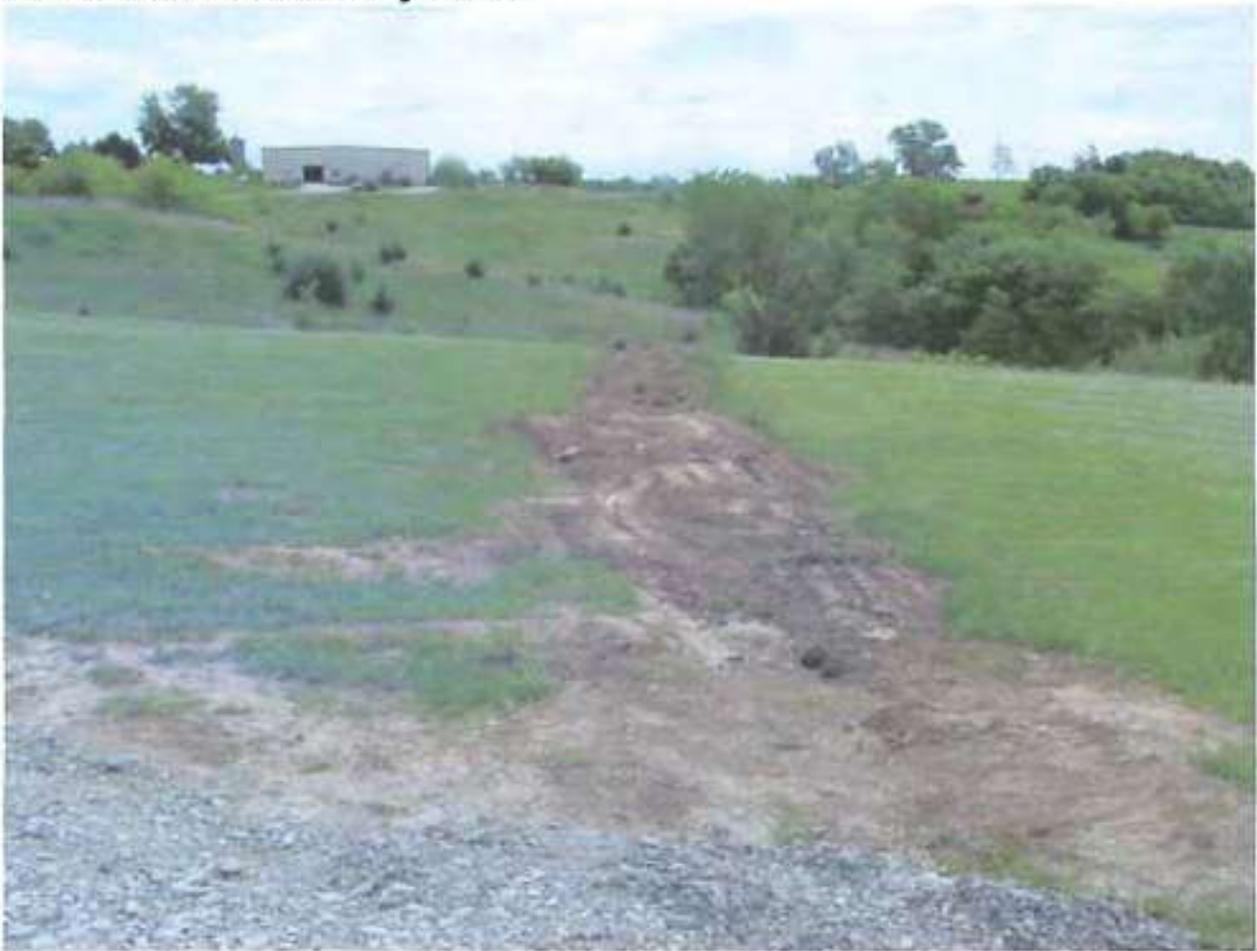
## 2006 Conservation Project - B

**The Problem** – New utilities have been install to the new facilities at Richardson Lake. The utilities have been burried to minimize the visual impact on the camp. The Utilities have been installed, but the ground has not been finished and reseeded. If left unrepaired, the area not only looks bad, but provides a location for erosion that will create ditches and fill in the lake.

**The Solution** – Shovel and rake the ground to smooth out to desired grade so that all ground will drain. Leave the original ditch location a little higher to allow for settling. Seed the area. Drag the new seed to create some cover for the seed. Cover the area withstraw or mulch if available.

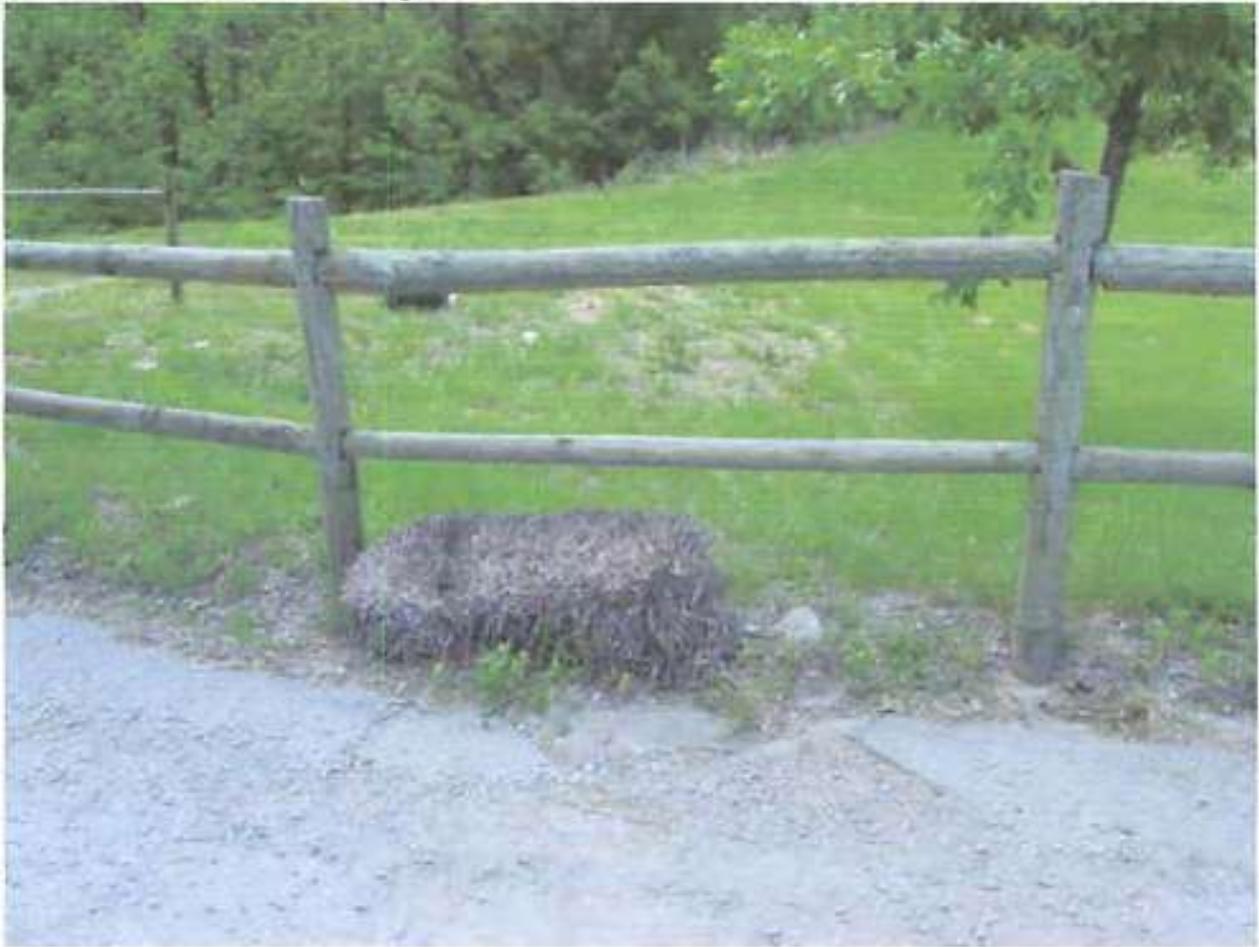
## 2006 Conservation Project - C

**The Problem** – Water from the drive and parking area adjacent to the trading post cannot get to the containment basin. The deposited earth along the edge of the drive forces the water to continue east until it washes down the road and creates new drainage problems.

**The Solution** – You need to allow the drainage into the containment basin. Dig a shallow swail where the bale of straw sets. Smooth out the ground so that the area will drain well. Seed the area. Create some cover for the seed either by dragging or by sprinkling some fine soil over the area. Cover the area with straw or mulch if available.

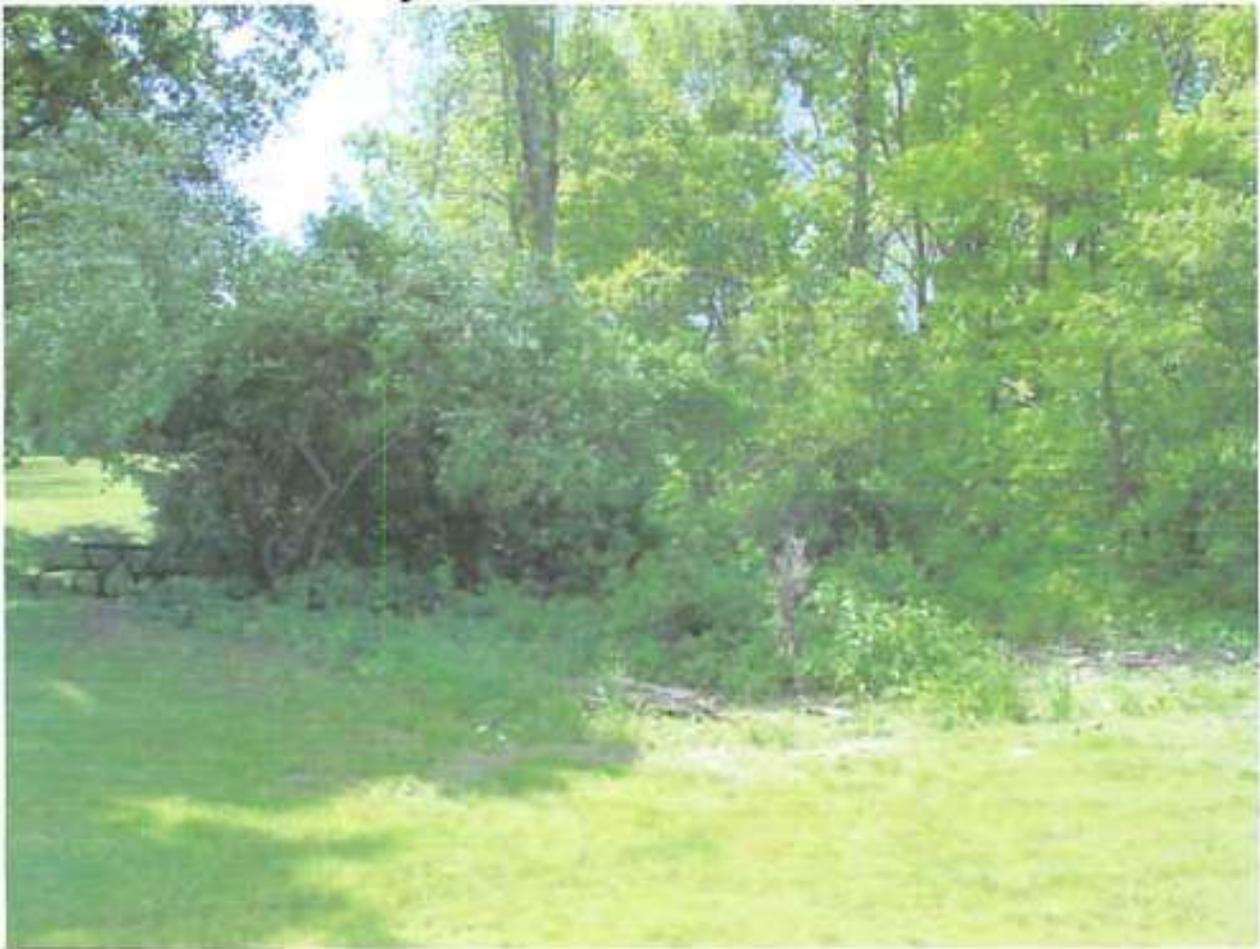
## 2006 Conservation Project - D

**The Problem** – Undesirable undergrowth has taken control of this wooded area just south of the tapping fire. It harbors undesirable vegetation and animals in a high use area.

**The Solution** – Clear undesirable vegetation. Remove dead wood and trash. Rake and clean the ground. Treat all stumps with broadleaf control.

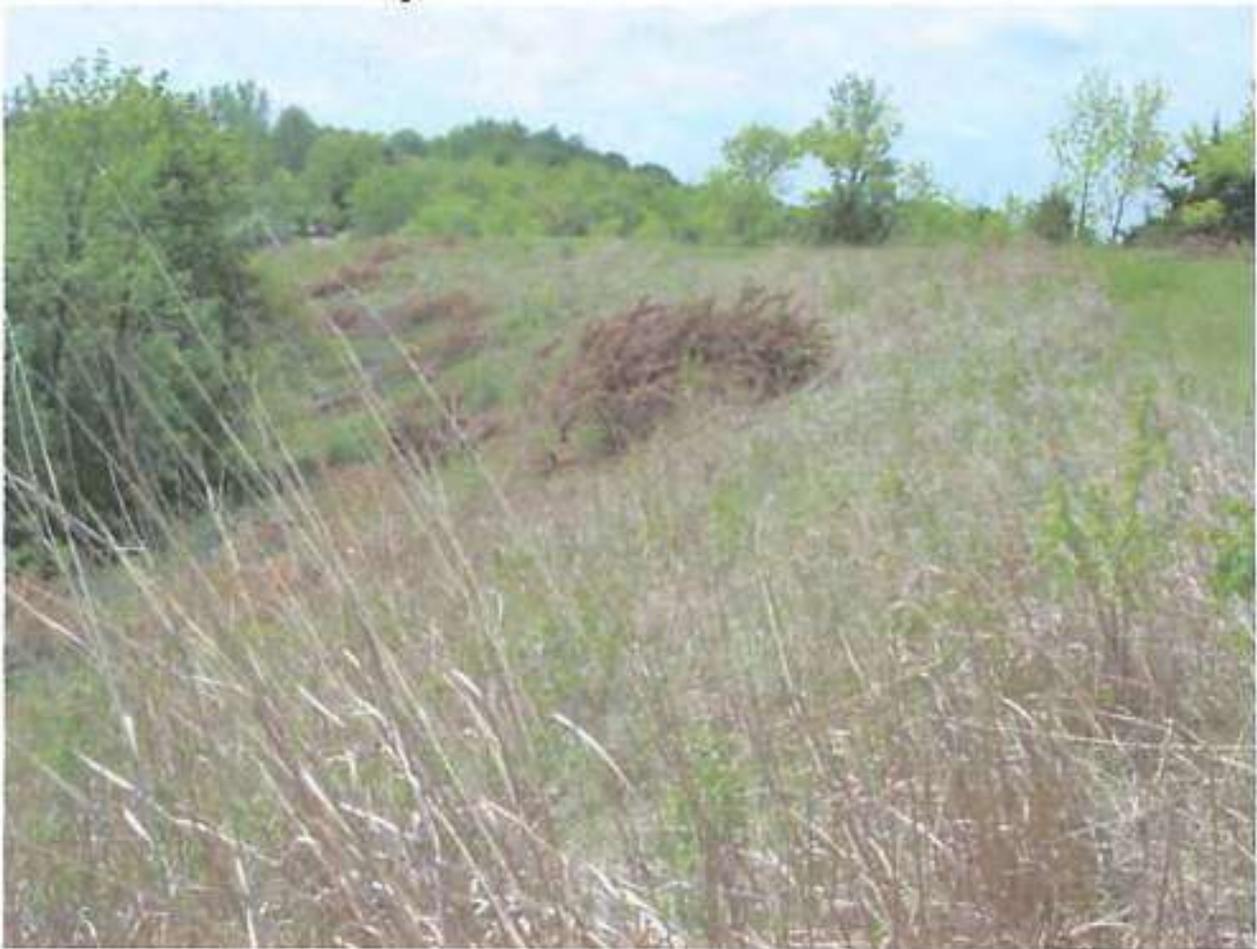
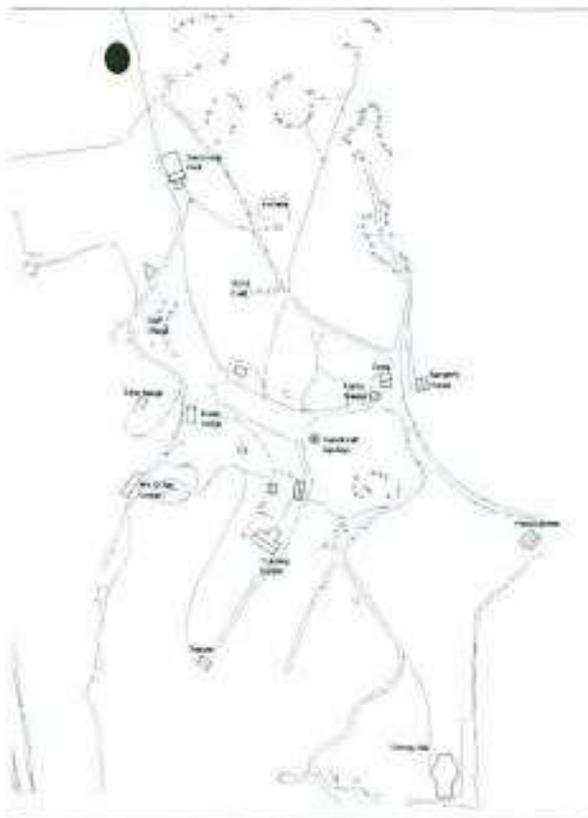
**The Problem** – The ridge is an area of Loess Prairie that was being invaded by transitional species of plants. Other scouting groups have worked to cut many of those transitional plants, but have not removed them so that the prairie grasses can flourish.

**The Solution** – The plants need to be brought to the road on the top of the ridge so that they can be easily transported to a burn pile. That can be done in any manner you consider easiest as long as it is not damaging to the surrounding grass areas.

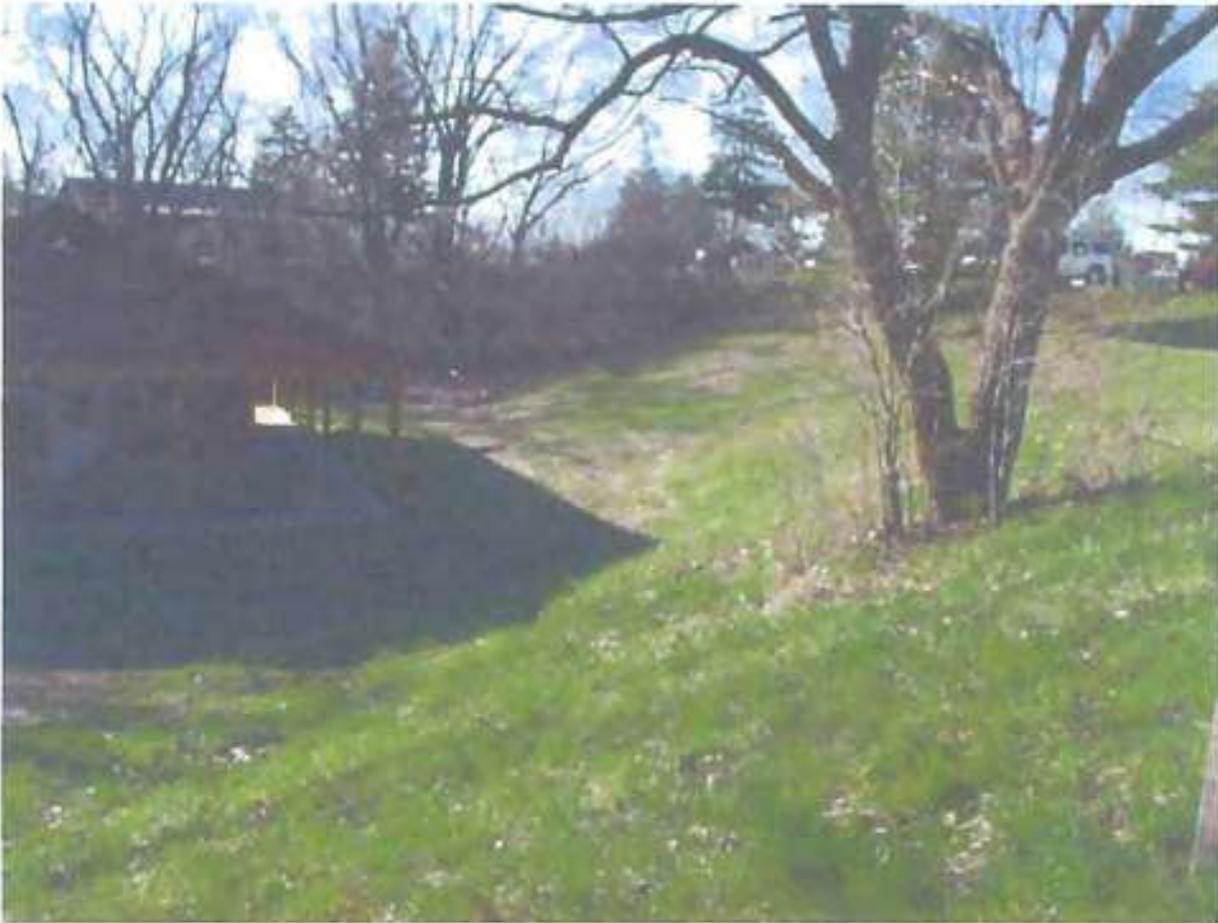
## 2008-A Conservation Project

The nature lodge was completed just in time for the 2007 camping season but the surrounding site has never been properly prepared and healed. Several projects should be performed.

Trim the undesirable voluntary tree growth (suckers) from around the specimen plants. Dispose of the waste material in an appropriate location so that it does not become groundwaste in the nearby woodlands.

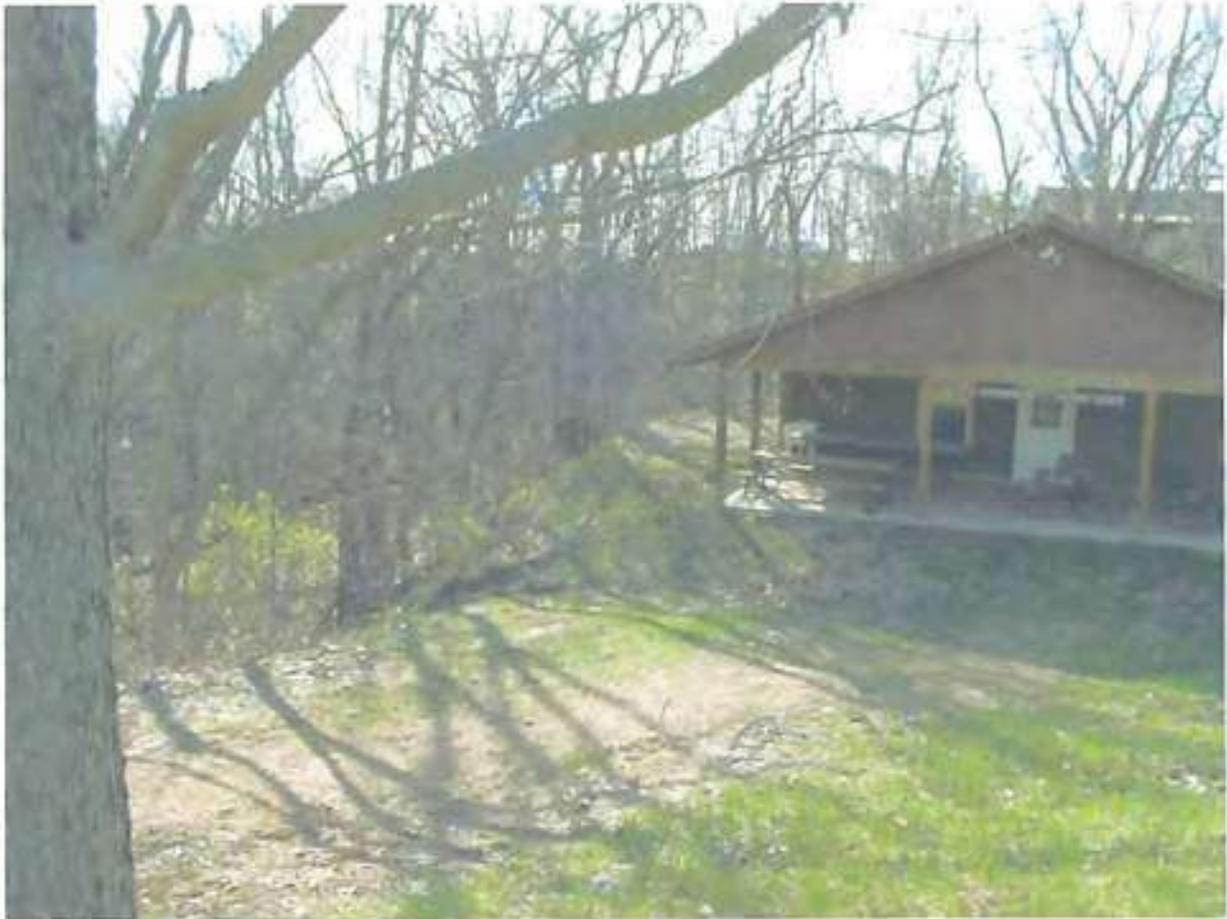
## 2008-B Conservation Project

The nature lodge was completed just in time for the 2007 camping season but the surrounding site has never been properly prepared and healed. Water from the lodge is diverted away from the buildings and into the adjacent woodlands to the south. The drainage way needs to be properly vegetated and the rundown to the woodlands should have stones placed to create diffusion, slow the drainage and reduce erosion from the water.

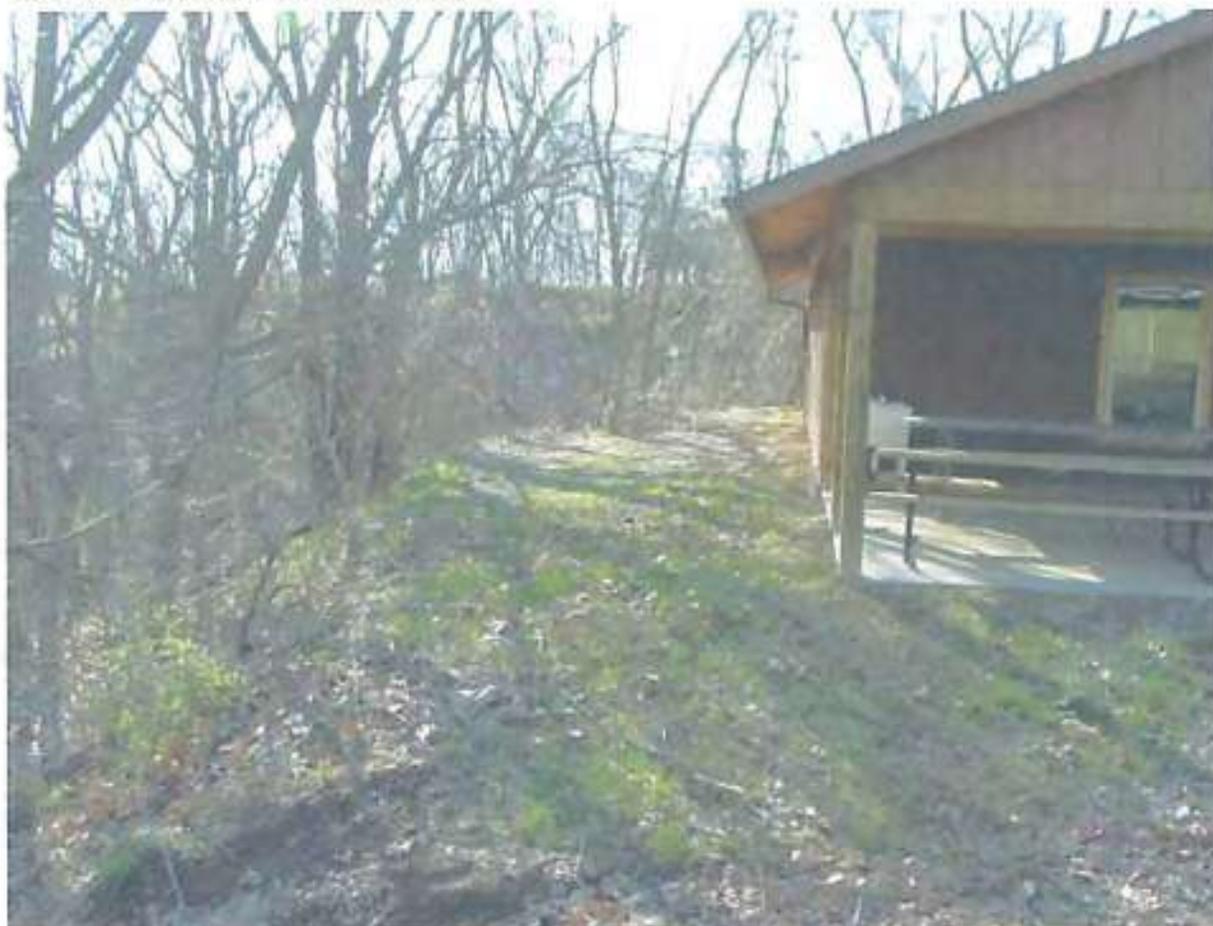
## 2008-C Conservation Project

The nature lodge was completed just in time for the 2007 camping season but the surrounding site has never been properly prepared and healed. The area adjacent to the building should be seeded and protected from pedestrian traffic. The area is showing some establishment from last year, but lightly overseeding could prove beneficial.

Fence off the newly seeded area to stop scouts from walking on the new seed. Water daily.

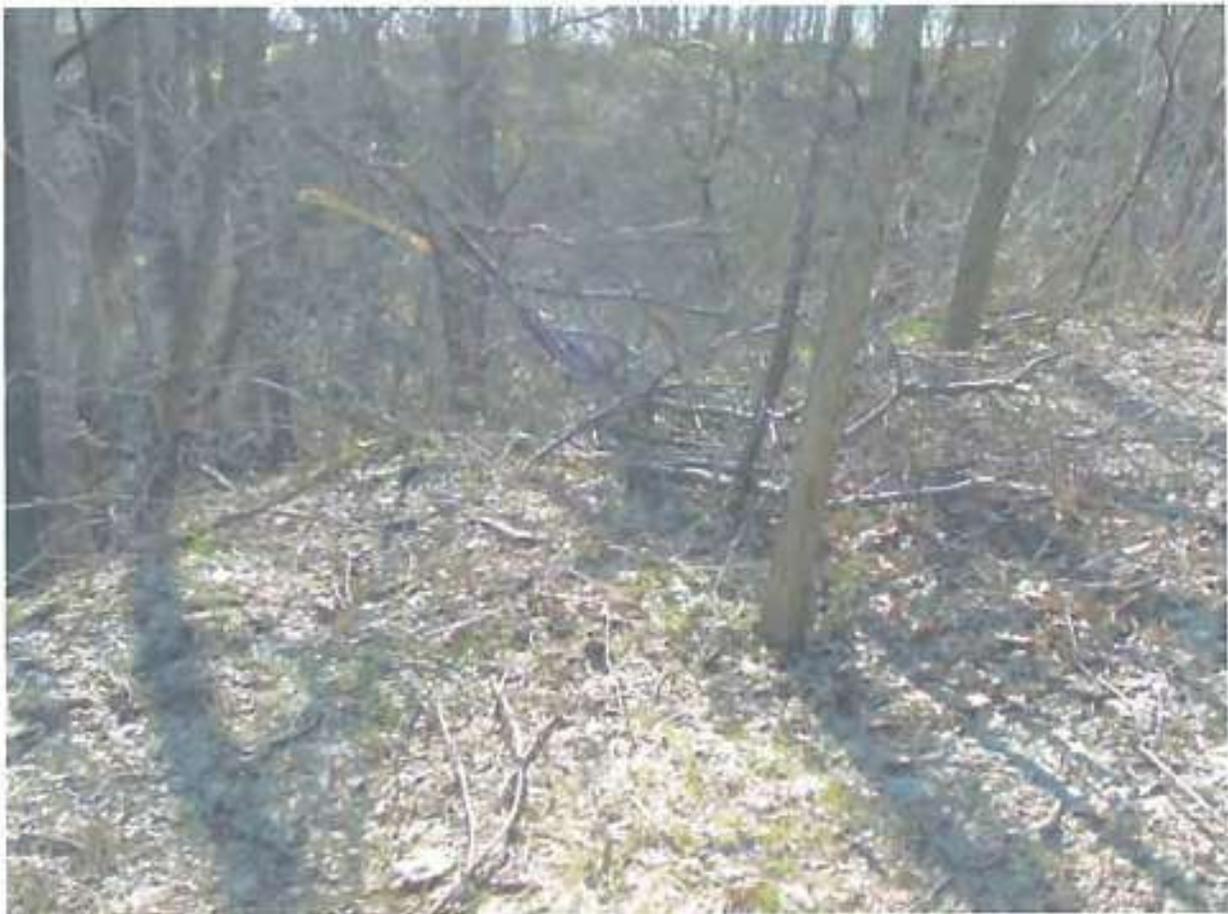
## 2008-D Conservation Project

The nature lodge was completed just in time for the 2007 camping season but the surrounding site has never been properly prepared and healed. Much of the wood trimmed for the construction of the lodge was tossed into the surrounding woodland.

Carefully remove dead underbrush within 100 feet of the nature lodge to allow undergrowth space to establish.

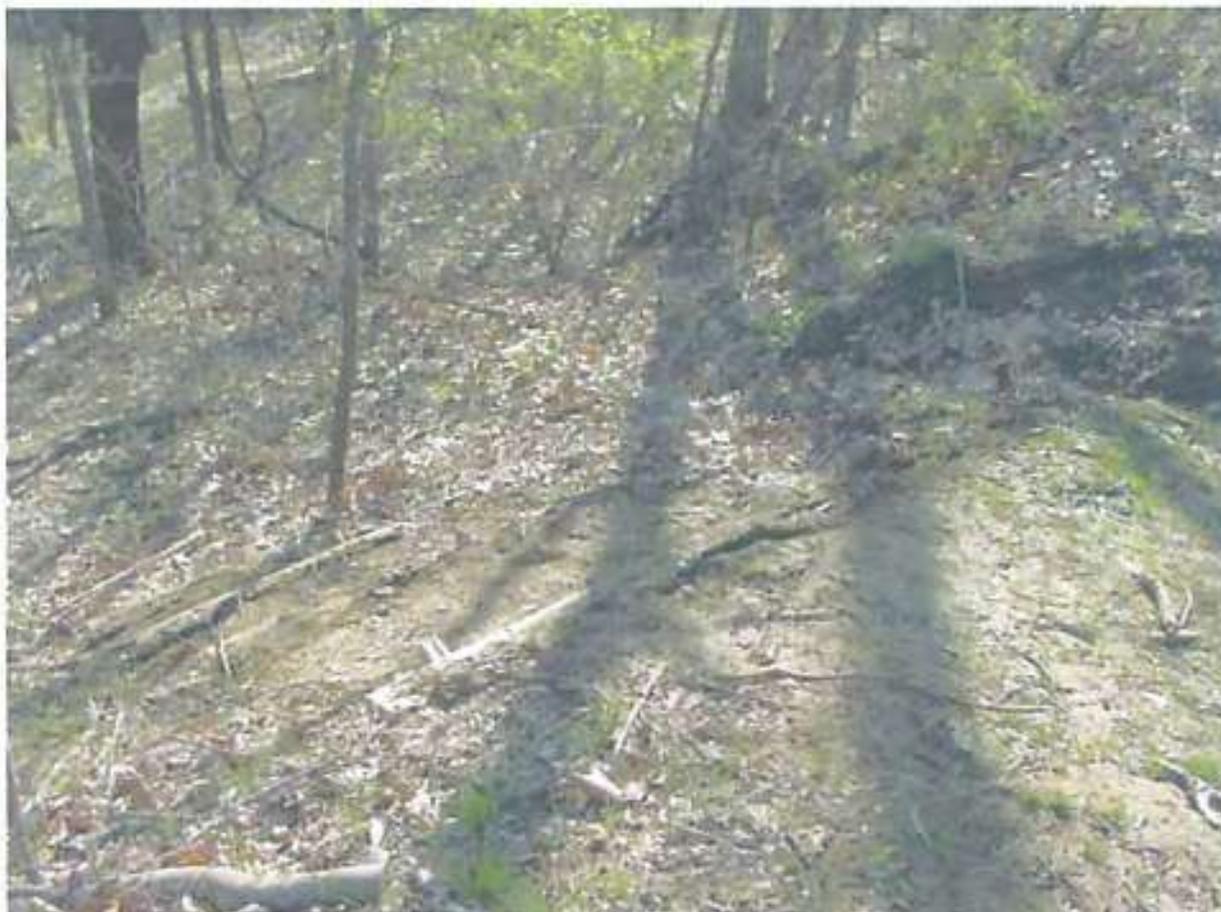
## 2008-E Conservation Project

A series of checkdams that act as a stairway to the nature trail were constructed during the 2007 camping season. The improvement was beneficial but could be better constructed.

Reconstruct the checkdams using old railroad ties or heavy timber lumber. Each stair should be separated at least 8 inches vertically and 18 inches horizontally from the next stair.

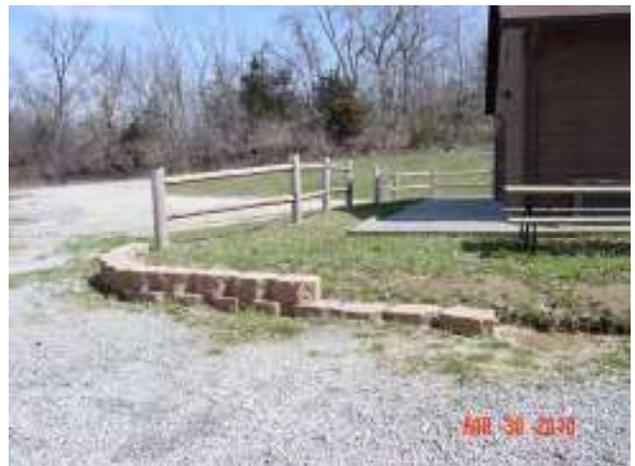
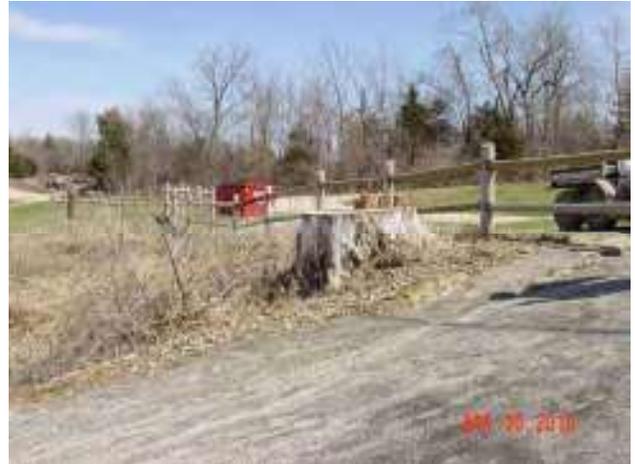
The project area is northwest of the trading post. Last year the Landscape Architecture merit badge class worked on a project that was constructing a CMU (concrete masonry unit) seating wall. The project progressed well but was never completed. The wall needs to be completed three blocks high. This will provide accessible seating to individuals who are not wheelchair bound.

Additionally, the area immediately northwest of that wall should be contoured and surfaced to make it accessible to Wheelchair bound individuals. This project should eliminate the need for a drive over the bank. That drive over the bank is currently the cause for erosion. This will also clean up and landscape an existing storm water detention area.

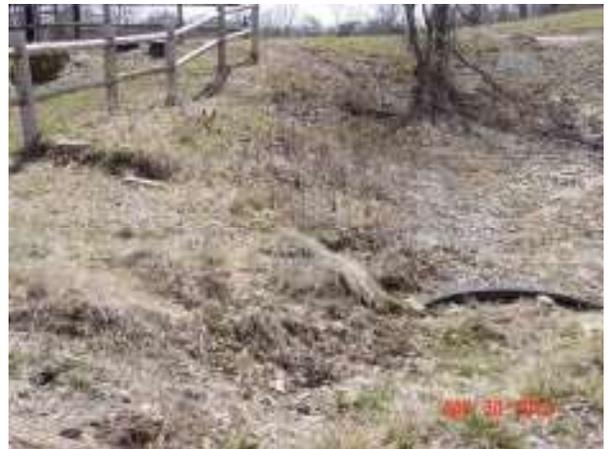
### **3. Storm water detention area southwest of the trading post.**

The storm water detention area southwest of the trading post was installed immediately after the development of the trading post. The earthen damn has since served as the eastern access route to the trading post. The remaining detention pond has largely been ignored. The area needs to be cleaned up, provided with an area for sedimentation and slow release, and reseeded. This project will provide conservation and beautify one of Camp Geiger's most popular features.

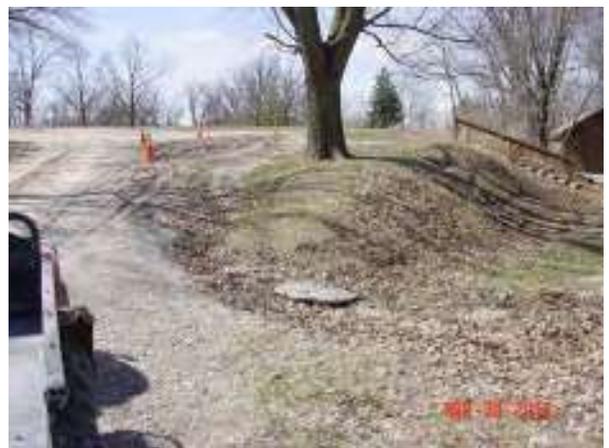
The old Camp Geiger Parking lot, which is now used primarily on Wednesday, Thursday, and Friday evenings creates substantial runoff. Many improvements have been performed to remedy the problems created, but over time we neglect to maintain those improvements and erosion results. Additionally, we exacerbate the problem with additional unrelated but contributing projects.

The catch basins, which were previously created, need to be uncovered and protected from damage. The drainage pipeline from those basins needs to be routed to avoid damage and the ditches need to be improved to avoid further erosion. Additionally, the wooded area to the north of the parking lot should be cleaned up a storm water detention area may be created to minimize down stream damage from runoff.

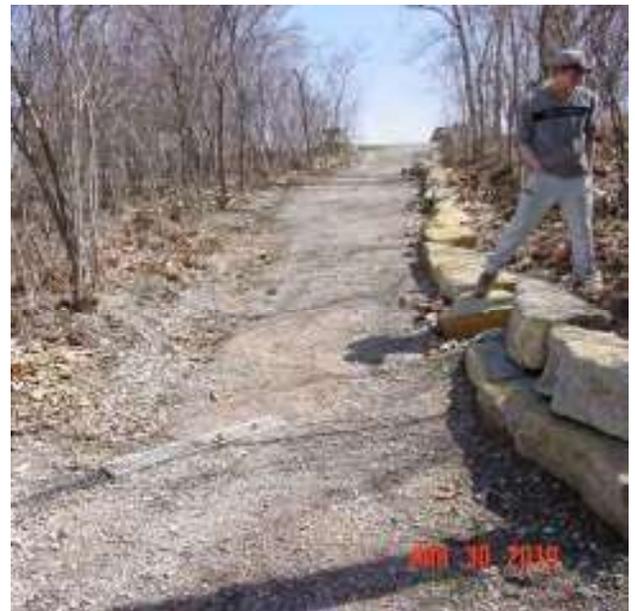
Since the development of the new Council Ring in 2008, the entry trail has been the source and victim of water damage. The trail was cut through a wooded thicket bound down hill. It collects water from the west end of the parking lot discussed in the previous project. Last year there was an attempt to control the drainage with terraces and with small inlets and buried pipe. The improvements do not appear sufficient to control the problem. There has been discussion about expanding the improvements to clear more of the adjacent woods. This area needs to be carefully studied to determine the best course of action.

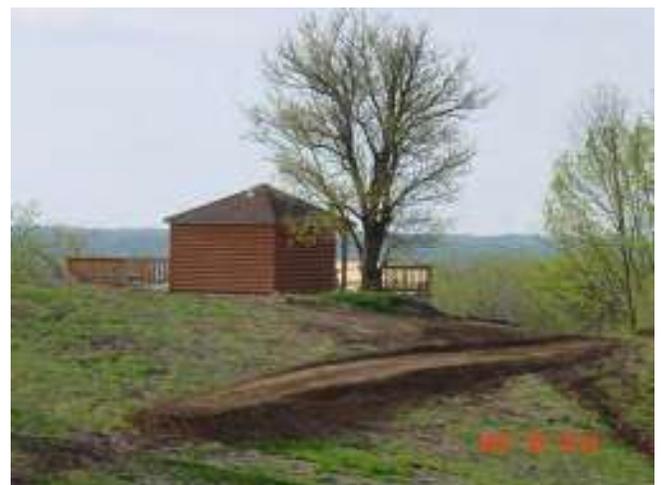
In 2009 the construction of new restrooms began on the site of the old Flying Eagle pavilion. Those restrooms will serve the new council ring. There was not a trail leading from the council ring to the restrooms. The creation of that new trail on the hillside will be a challenge to assure that new erosion problem are not created.

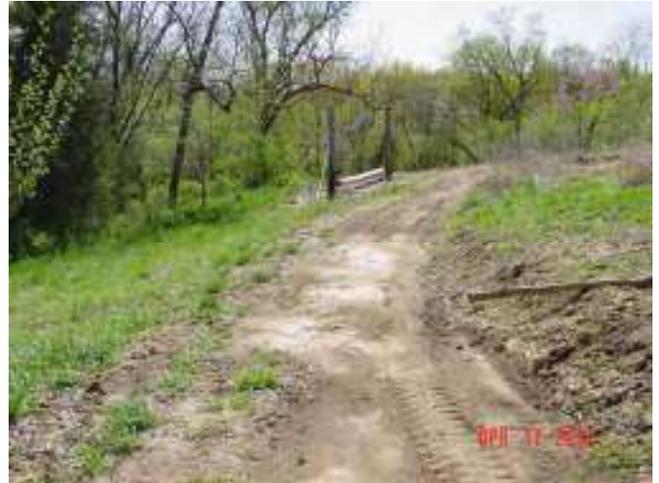
A new cope course was constructed to make room for the new shooting range. That copy course caused a number of soils areas to be disturbed and should be quickly reseeded to minimize soil erosion.

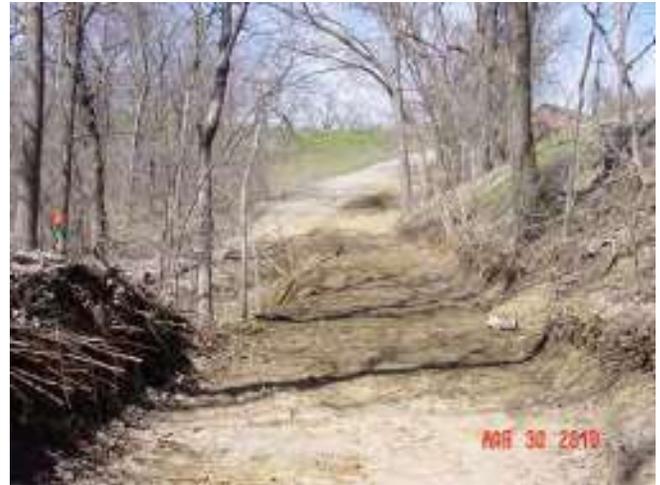
**1. New trail from the trading post to headquarters and the dining hall. This is the continuation of a 2010 project.**

This trail began development over a year ago and was part of the 2010 conservation plan. It will continue through the development process in the years to come. Only the western end of the trail adjacent to the entry road has been fully developed. The remainder of the trail seems to be searching for direction. There will be a continued need for development and repairs for the trail for several years to come.

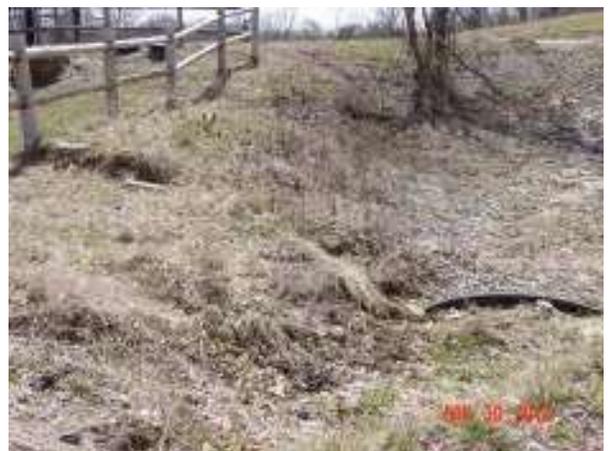
**2. Storm water detention area southwest of the trading post. This is the continuation of a 2010 project.**

The storm water detention area southwest of the trading post was installed immediately after the development of the trading post. The earthen dam has since served as the eastern access route to the trading post. The remaining detention pond has largely been ignored. The area needs to be cleaned up, provided with an area for sedimentation and slow release, and reseeded. This project will provide conservation and beautify one of Camp Geiger's most popular features.

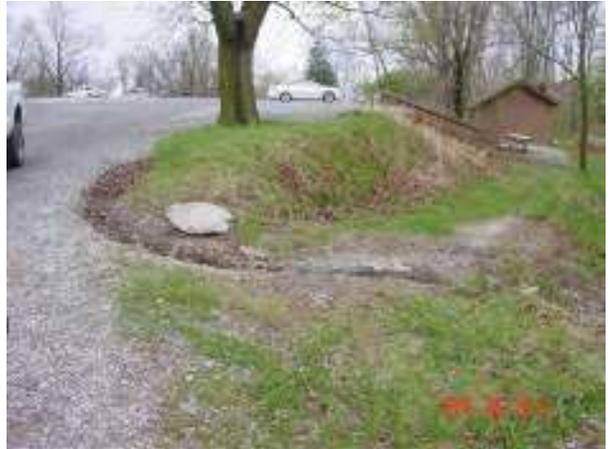
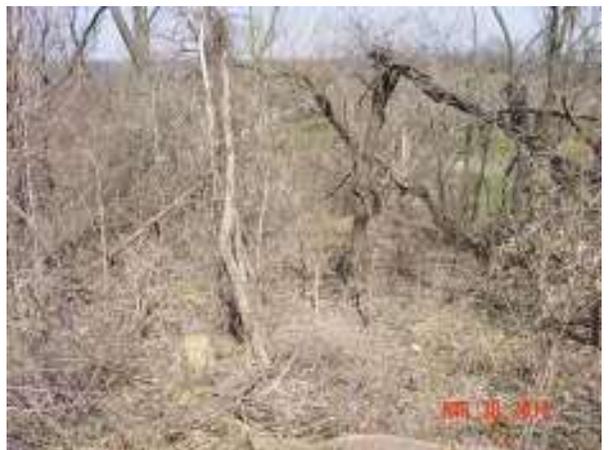
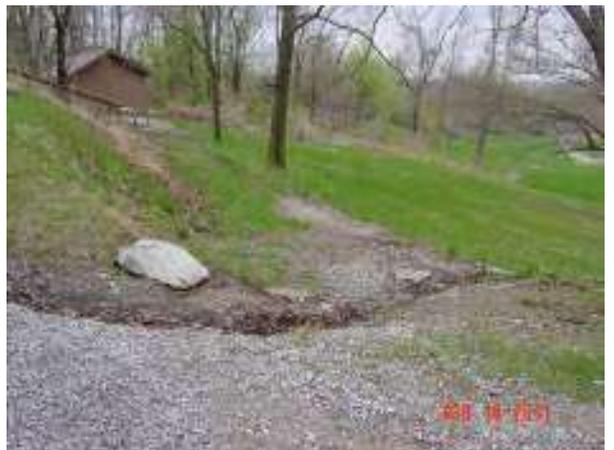
**3. Parking Lot Drainage improvements. This is the continuation of a 2010 project**

The old Camp Geiger Parking lot, which is now used primarily on Wednesday, Thursday, and Friday evenings creates substantial runoff. Many improvements have been performed to remedy the problems created, but over time we neglect to maintain those improvements and erosion results. Additionally, we exacerbate the problem with additional unrelated but contributing projects.

The catch basins in the parking lot have been improved and protected. The drainage pipeline from those basins still needs to be rerouted to avoid damage and the ditches need to be improved to avoid further erosion.

It is suggested that a small detention area be created in the trail to the old restrooms. A 6 inch tube should be buried from that detention area to the bottom of the valley to stop the erosion on the northern slope of taper valley.

Additionally, the wooded area to the north of the parking lot should be cleaned up a storm water detention area may be created to minimize down stream damage from runoff.

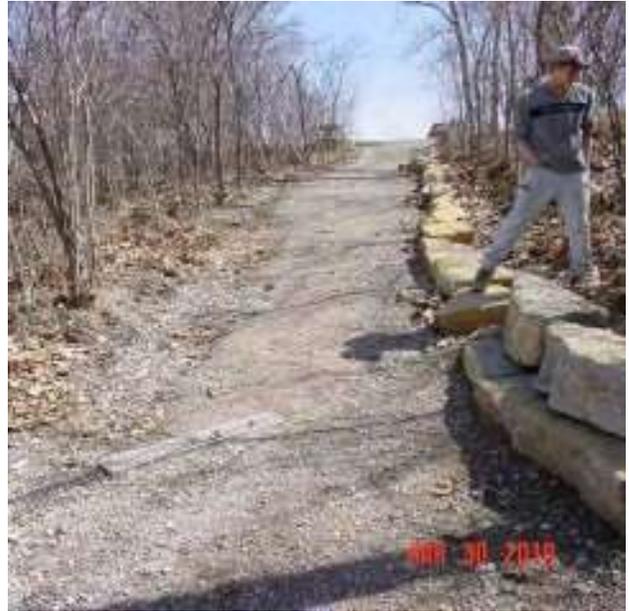
Since the development of the new Council Ring in 2008, the entry trail has been the source and victim of water damage. The trail was cut through a wooded thicket bound down hill. It collects water from the west end of the parking lot discussed in the previous project.

The drainage originating from the top of the trail needs to be diverted to the north side of the trail to stop the drainage from continuing down the trail.

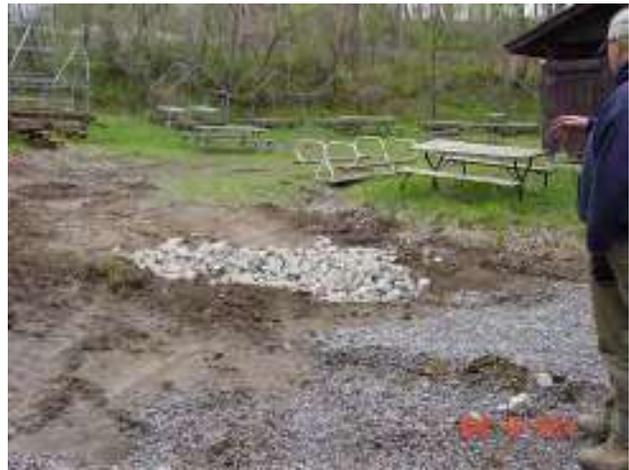
Tubes were installed to handle drainage that collects from a very old camp trail. The collection ends of the tubes must be repaired to avoid further damage.

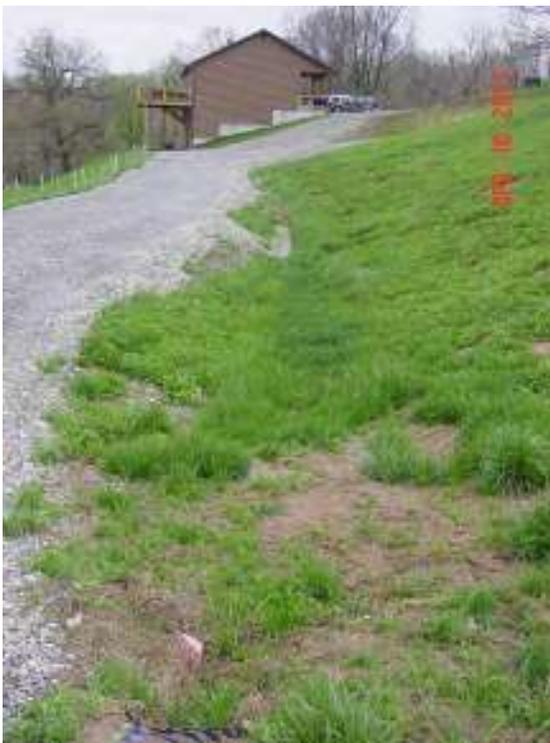
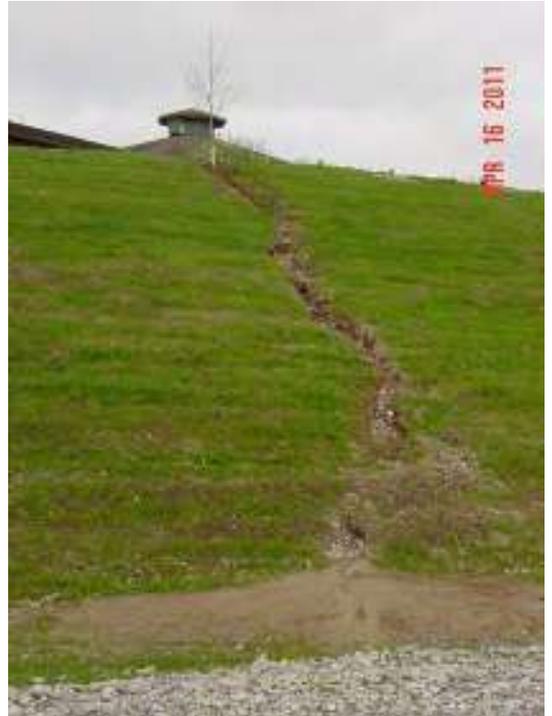
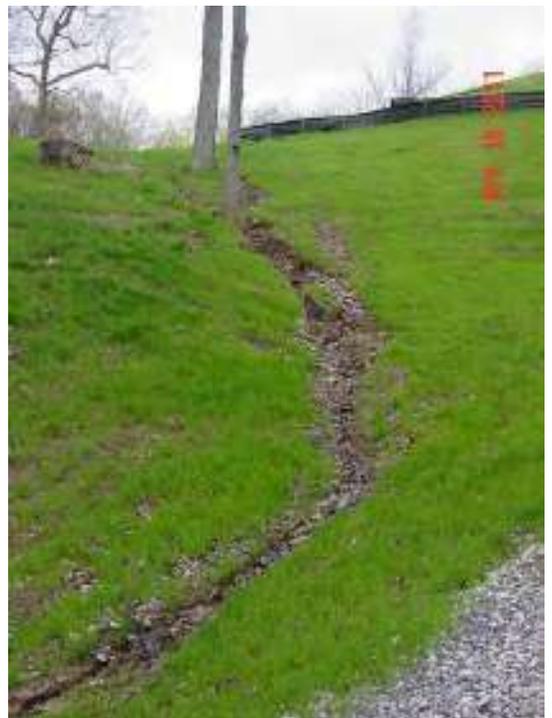
**Vegetation of the COPE Course.**

A new cope course was constructed just over a year ago to make room for the new shooting range. That copy course caused a number of areas to be disturbed and should be quickly reseeded to minimize soil erosion. Most of the problems were repaired in the past year, but recent improvements continue to require additional needs for conservation repairs. This issue will take a couple of years to fully repair.

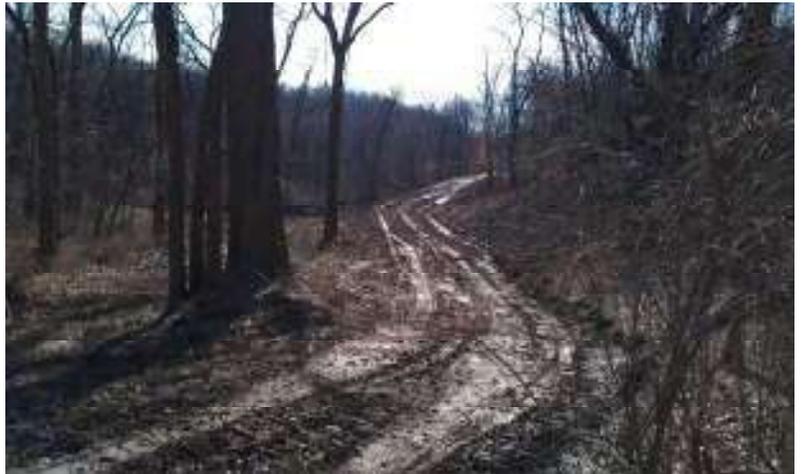
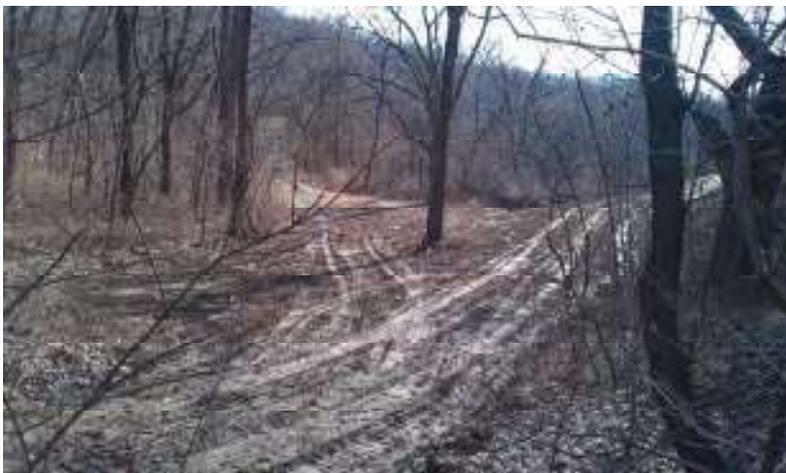
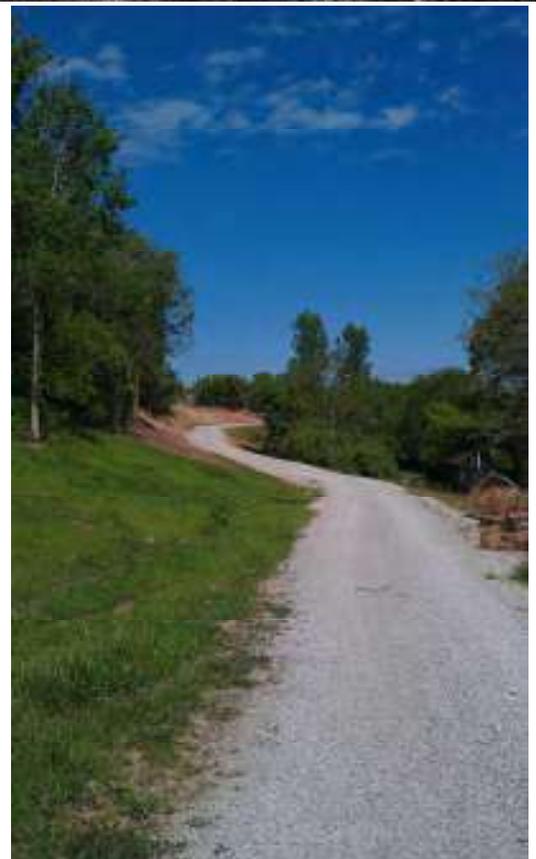
### 1. Road improvements to campsite improvements.

in demand and the facilities committee is working to accommodate a reasonable growth. Two areas which are seen as deficient to handle additional scouts are campsites and dining. Several of the campsites are to be improved but the access to them is insufficient for equipment and crews to complete work. The roads are cut and being improved but will require much additional care to assure that the land is properly healed and that drainage problems are addressed to minimize unintended consequences. These projects are still in progress and will require additional review as camping season approaches.

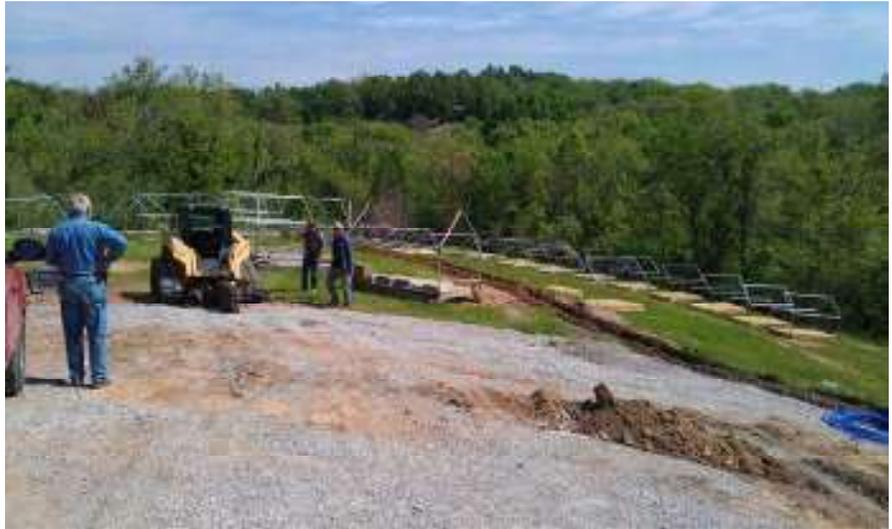
## **2. Kickapoo Campsite Improvements.**

In order to more safely locate troops to away from weather dangers, the facility committee began work to enlarge the old Kickapoo campsite. Those improvements are currently underway and will be in use for the 2012 season. The improvements will

also require additional planning and development to assure that the development is properly revegetated.
