## NATURAL RESOURCE CONSERVATION MANAGEMENT FIVE YEAR IMPLEMENTATION PLAN

### CAMP GEIGER

## PONY EXPRESS COUNCIL BSA

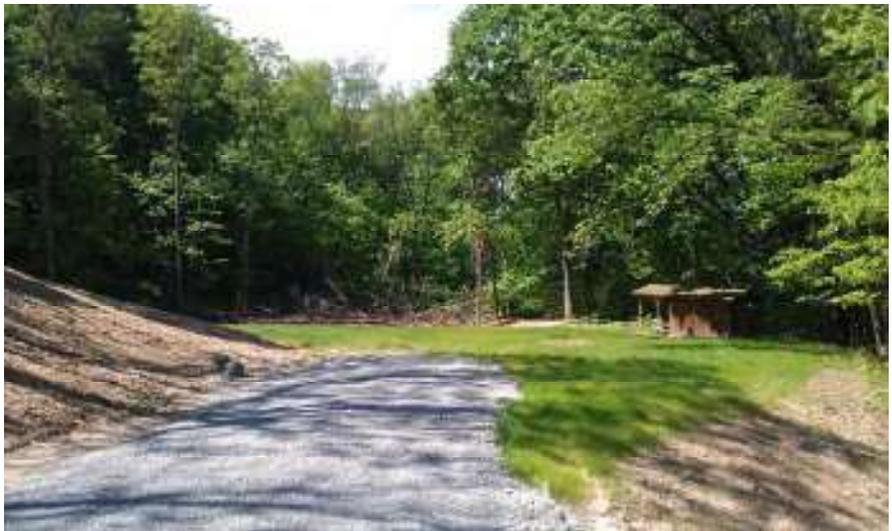
## **3. Short Arrow Campsite Improvements.**

Short arrow campsite is in the process of being rebuilt. New roads to the area have been constructed and will also require healing. Old roads are being abandoned must be correctly returned to nature. The campsite is still under construction

and the specific nature of conservation needs is not yet know but a plan will be necessary to assure final project success.

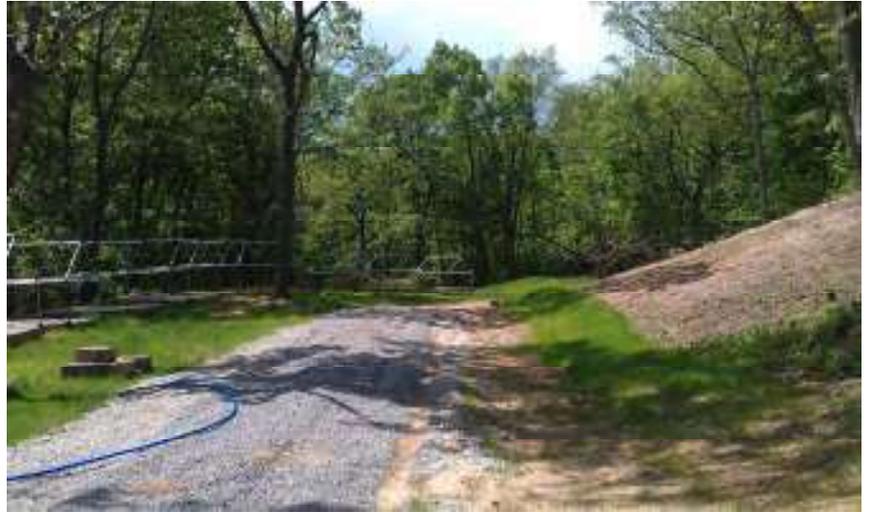
## **4. Buffalo Bill Cody Campsite Improvements.**

Buffalo Bill Cody was a campsite in an older plan of Camp Geiger that has long been abandoned. With the need for additional scout housing the campsite is in the process of being rebuilt. New roads to the area have been constructed and will also require healing. The campsite is still under construction and the specific nature of conservation needs is not yet known but a plan will be necessary to assure final project success.

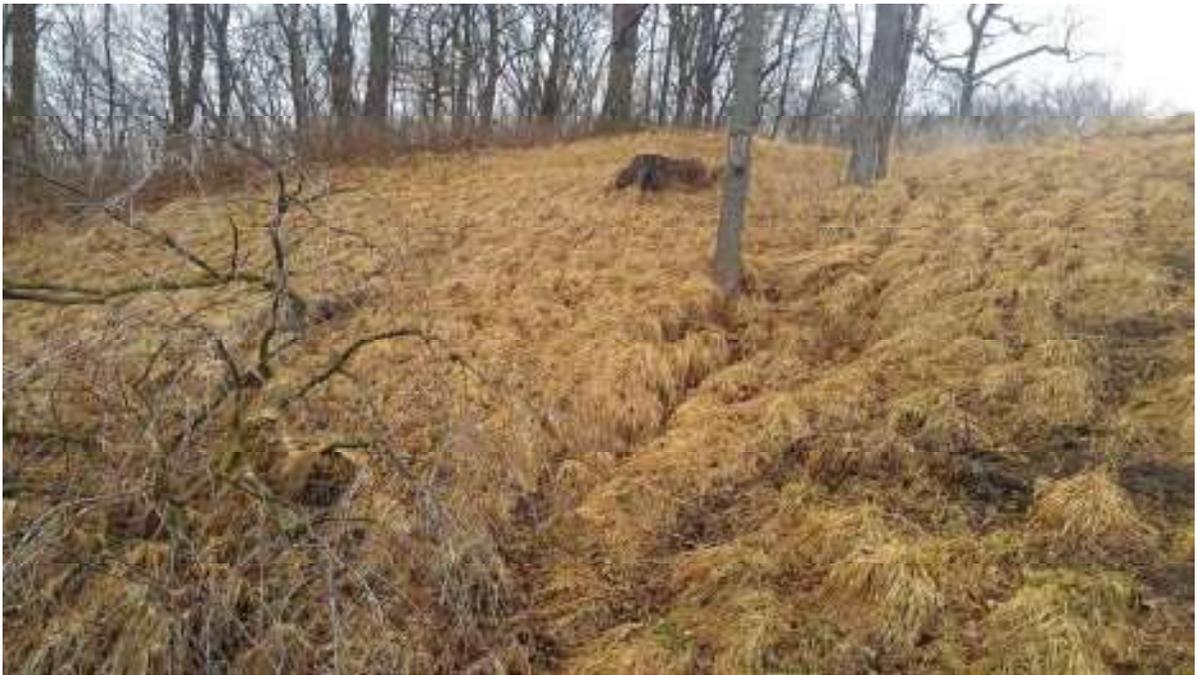
In the past few years the council has expanded the shooting sports area to accommodate many more participants. In order to create enough level areas for the shooting ranges, many new embankments were created. Most have been adequately corrected but some will still require more work. This area southeast of the rifle range has substantially healed over but still requires a little extra work.

Rubble fill will help defuse drainage in the area. That rubble can be found nearby in the limestone hills.

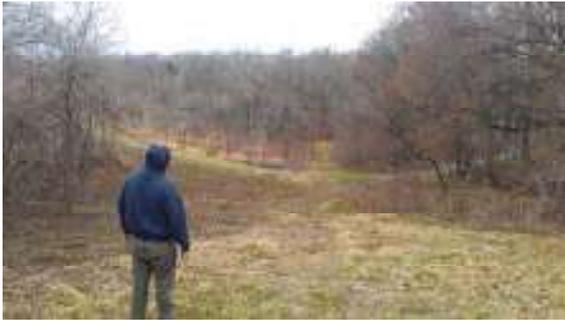
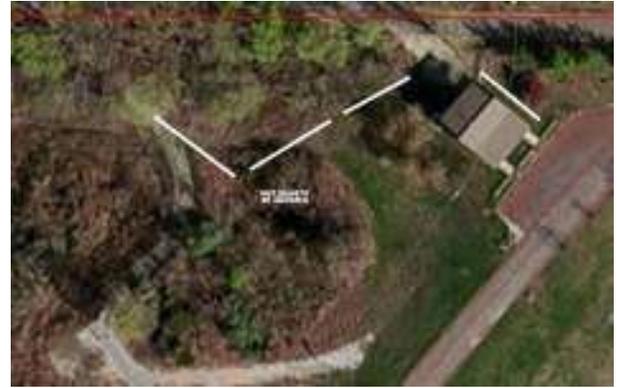
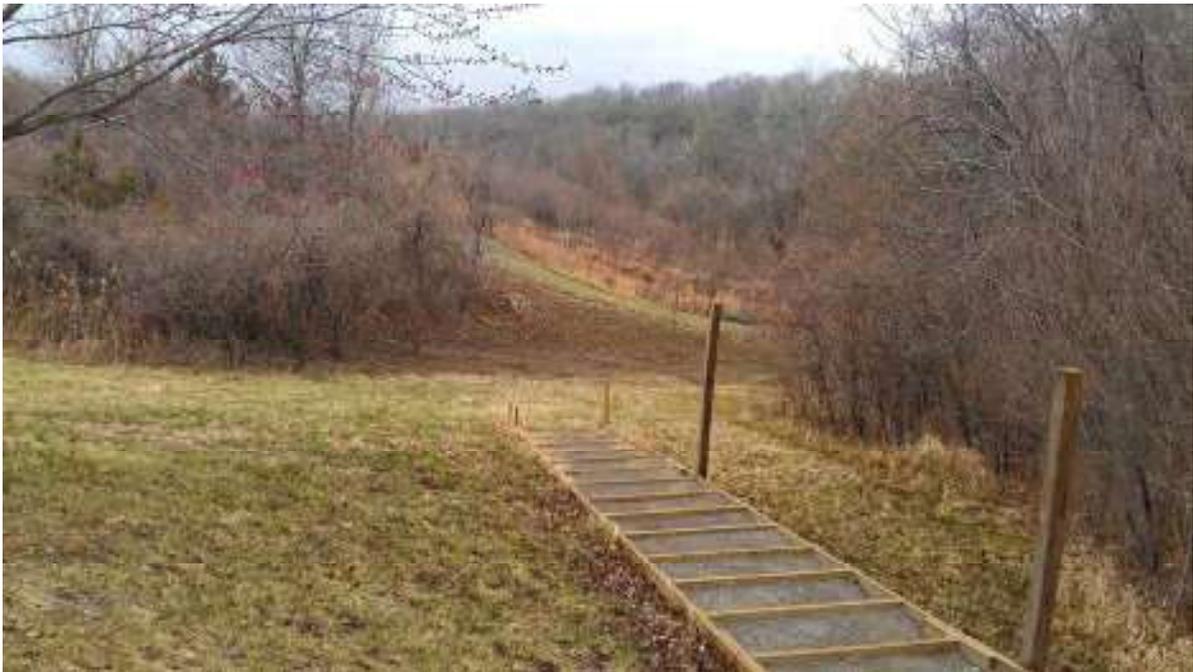
## **2. Trail from the Administration / Health Lodge to the Silver Eagle Trail.**

Last year the Adult Foxman program began working on a trail from the front entry to the Health lodge to the Silver Eagle Trail. The purpose of the trail is to keep campers from walking on the camp roads. Many questions and suggestions have been received about the trail. The design of the trail is to continue toward a clearing and then double back to tie into the Silver Eagle Trail. The Silver Eagle Trail may need a drainage tube but that will be located north of where the trails unite.

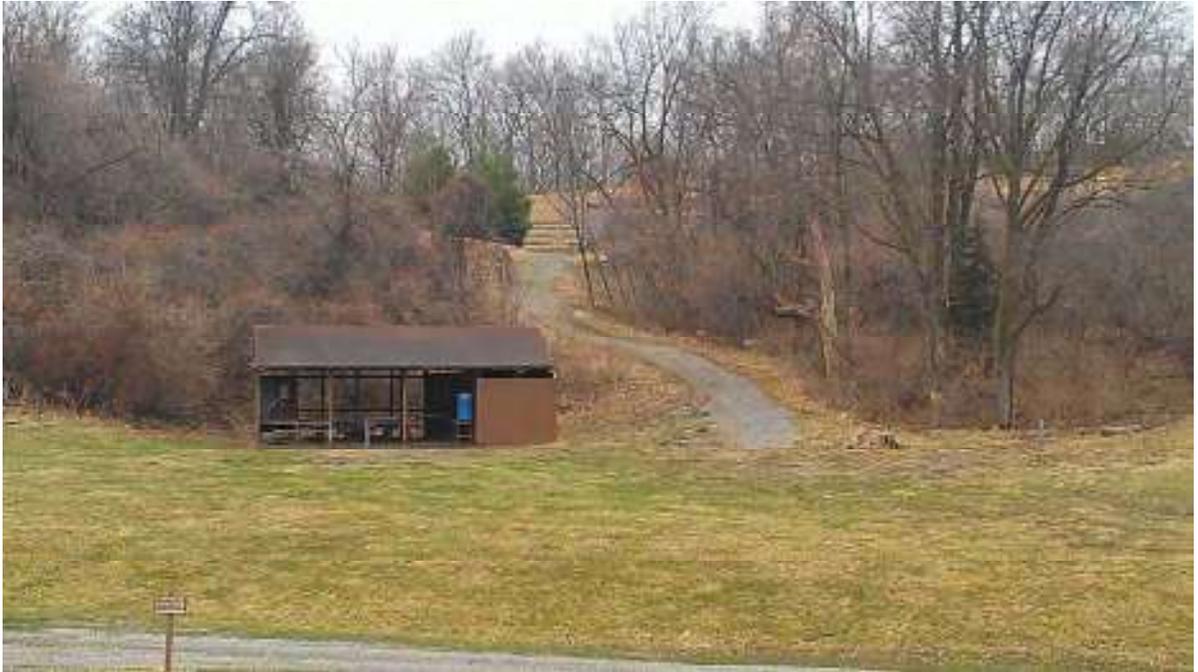
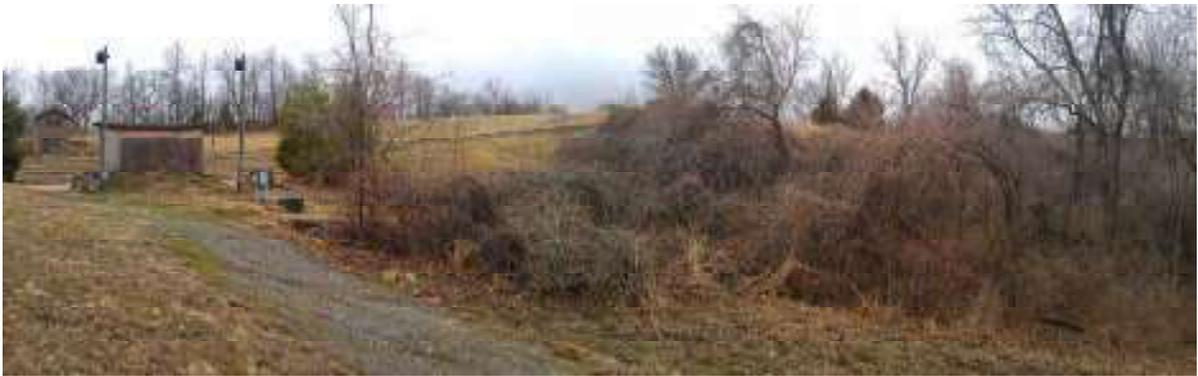
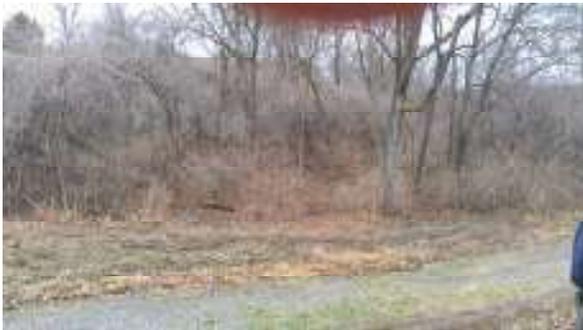
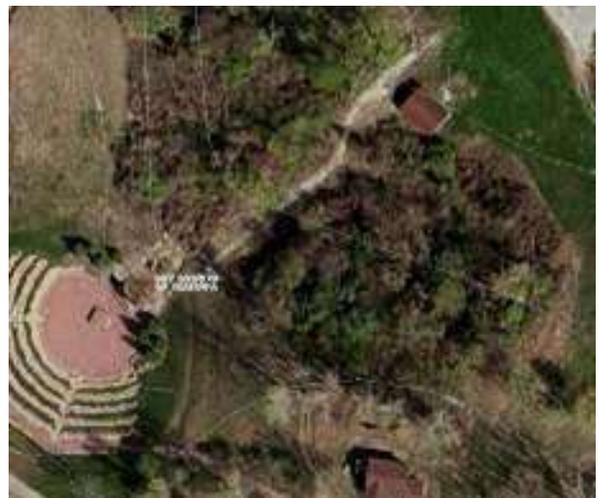
### **3. Trail Improvements North out of the Running Horse Council Ring.**

Many changes have been created since the creation of the Running Horse Council Ring. The area is now be used as a staging area for troops at Wednesday night campfire but is also being considered as an area for troop departure to separate troops from the visitors for a smoother transition after family visits. The area needs aesthetic improvements as well as clearing and creation of a drainage detention pond just to the west of the trail.

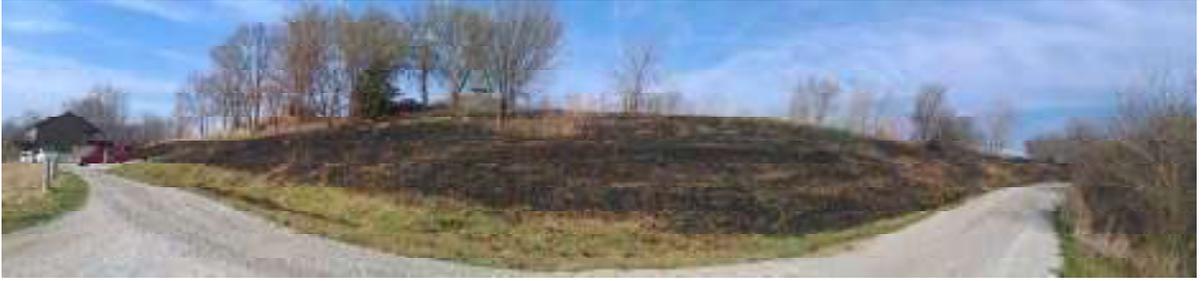
#### **4. Native Grass area just East of the Dining Hall.**

The area just east of the Dining Hall has recently been planted in native grasses. Several areas of camp have been established with native grasses but all require additional prairie management techniques including controlled annual burns. Grasses are well established but the area needs to be cleaned up and undesirable vegetation must be eliminated. Some special plantings of

noninvasive species may be added in select areas to enhance wildlife food and cover.

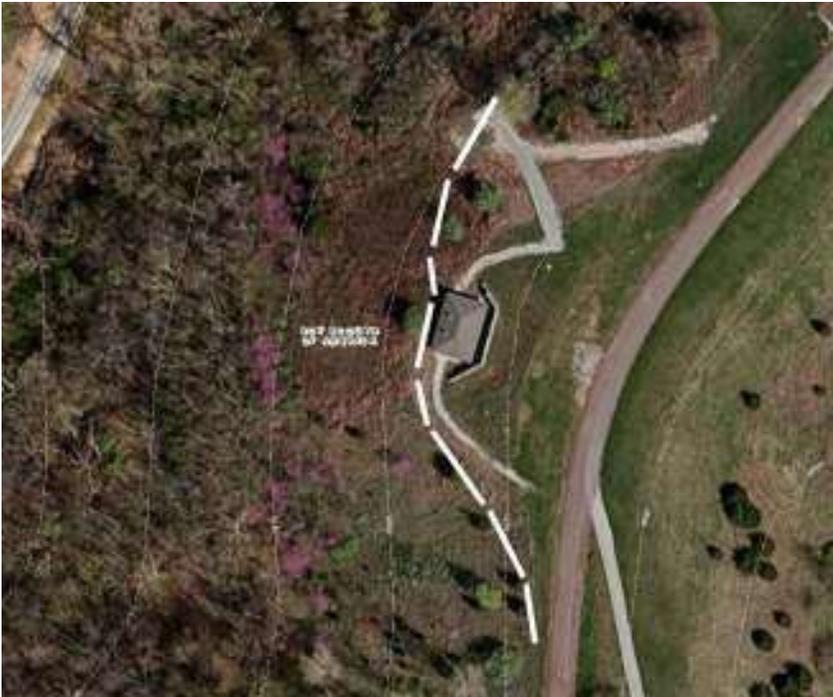
### 5: Upper Silver Eagle Trail

The upper end of the Silver Eagle Trail was never properly completed. The route for the upper portion of the trail is shown below and should be completed to finalize the project.

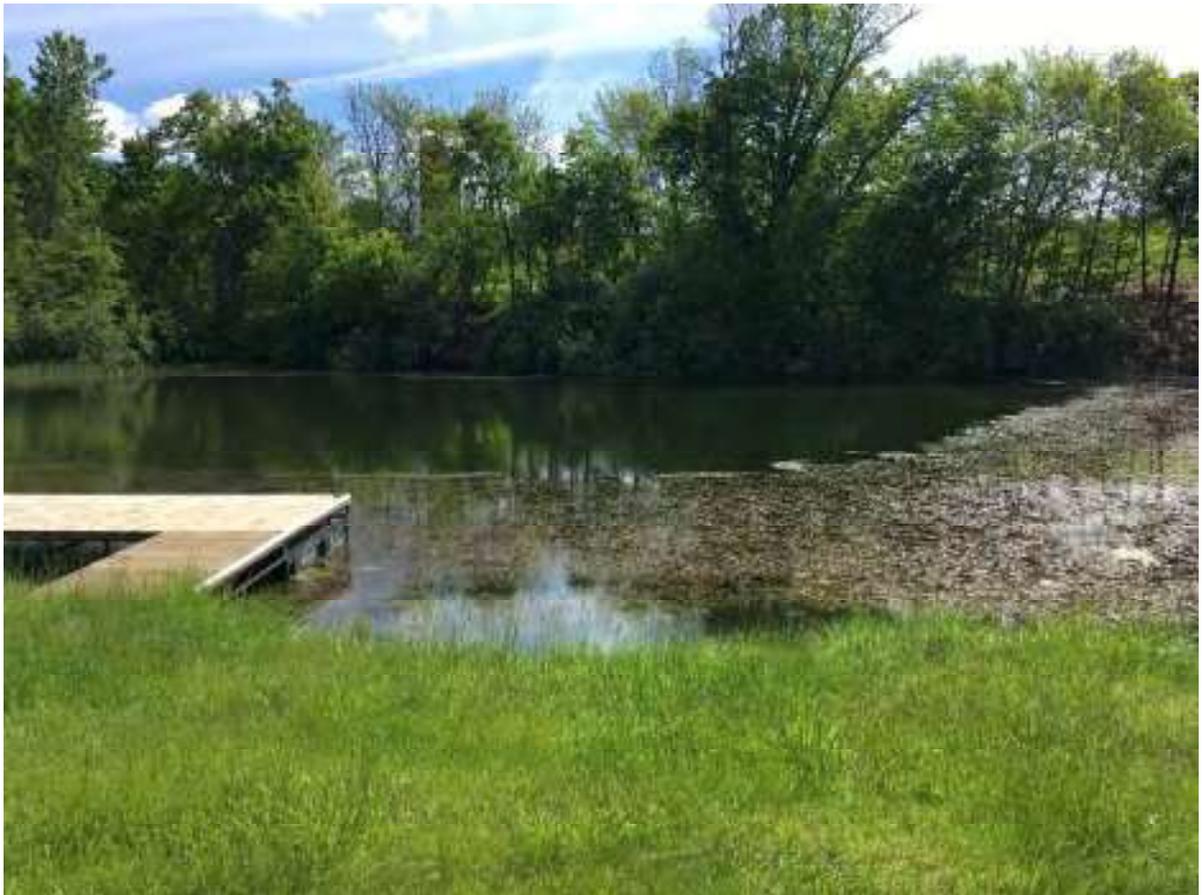
In recent years the vegetation on the east side of Lake Richardson has grown out of control reaching the water. This provides undesirable change that starts a modification in the character of the lake. It is the desire of Camp Geiger to stop this transition so that the lake may remain recreational for program. Areas of the bank have now been cleared. Continued progress and maintenance of repaired areas should be considered.

The vegetation removal may be accomplished by many participants. The process can be done with many different means. Chainsaws for those properly trained and qualified. Clippers and loppers are appropriate for those younger. It is essential that the project be accomplished as quickly as possible. Substantial amounts of poison ivy will require extra care in working with the vegetation.
